Performance of Confined Masonry Buildings in the February 27, 2010 Chile Earthquake

Svetlana Brzev, Maximiliano Astoza and Maria Ofelia Moroni Yadlin

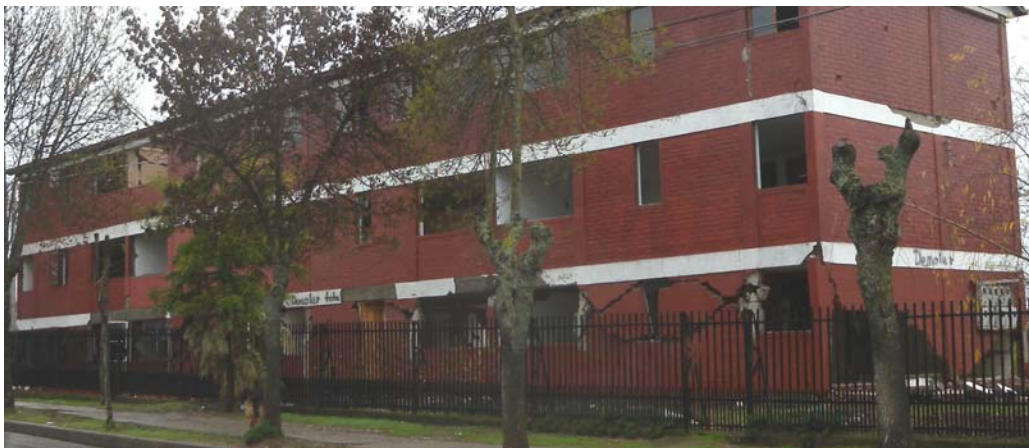
The most common damage pattern observed in masonry walls was in-plane shear cracking. This type of damage was mostly observed at the bottom floor level of three- and four-storey buildings, as shown in Figure 4 a and b. In a very few cases, this damage pattern was observed in single-family dwellings,

Figure 4. In-plane shear failure of masonry walls: a) a three-storey building in Cauquenes experienced severe damage at the ground floor level; b) a closer look into damaged walls in the same building, and c) shear cracking in a brick masonry wall of a two-storey single family house.

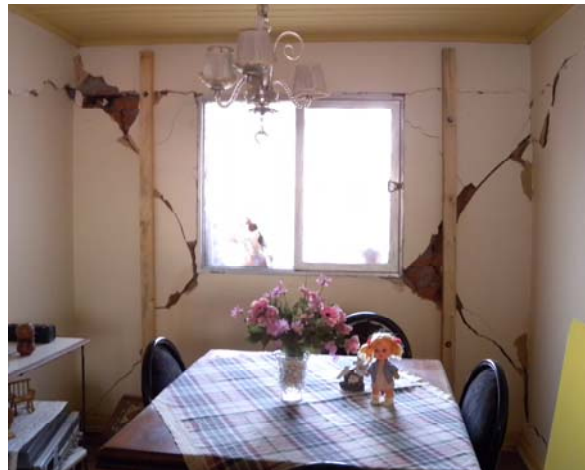
c)

again at the first floor level of a two-storey building, as shown in Figure 4 c. Shear cracking was observed in walls built using all types of masonry units, including hollow clay tiles, clay bricks, and concrete blocks. Note that the walls in the building shown in Figure 4 a and b were built using hollow clay blocks, while the wall shown in Figure 4 c was built using clay bricks.

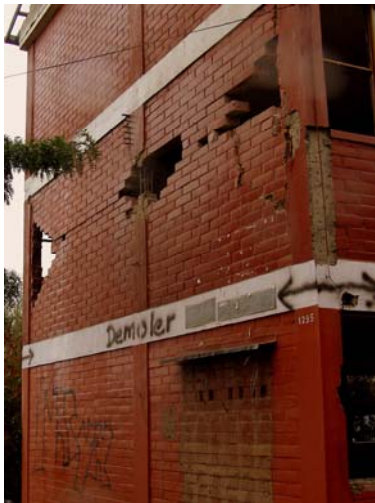
A few instances of out-of-plane wall damage were observed. Most notable example was a three-storey building in Cauquenes in which the damage was concentrated at upper floors, as shown in Figure 5. The building had RC floors and a timber truss roof. Cracks in the third-floor wall panel extended into the RC tie-beam, as shown in Figure 5 b (note that the tie-beam is wider than the wall). The out-of-plane damage was observed in the transverse direction of the building. The same building suffered extensive damage in the longitudinal direction at the ground floor level (see Figure 4).

Figure 5. Out-of-plane damage of masonry walls in a three-storey building: a) second floor level, and b) third (top) floor level.

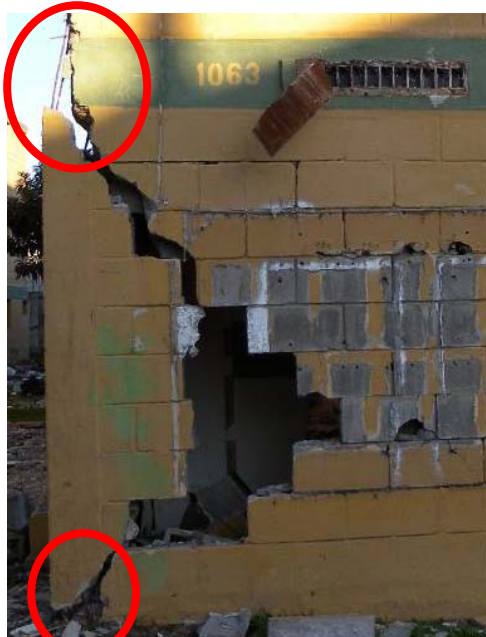
Failure of RC tie-columns was observed in three- and four-storey apartment buildings in which masonry walls suffered severe damage at the ground floor level. Absence of ties at the tie-beam-to-tie-column joint, and inadequate anchorage of longitudinal reinforcement caused shear failure at the tie-column ends (see Figure 6 a). Buckling of longitudinal reinforcement was observed where size and/or spacing of ties at the tie-column ends was inadequate and the masonry crushing was severe, as shown in Figure 6 b. The buckling took place due to excessive axial compression stresses in tie-columns which developed after the masonry was crushed at the wall toe.

Figure 6. Failure of RC tie-columns: a) shear failure at the ends of a RC tie-column (note an absence of ties in the joint area), and b) buckling of longitudinal reinforcement at the base of a RC tie-column.

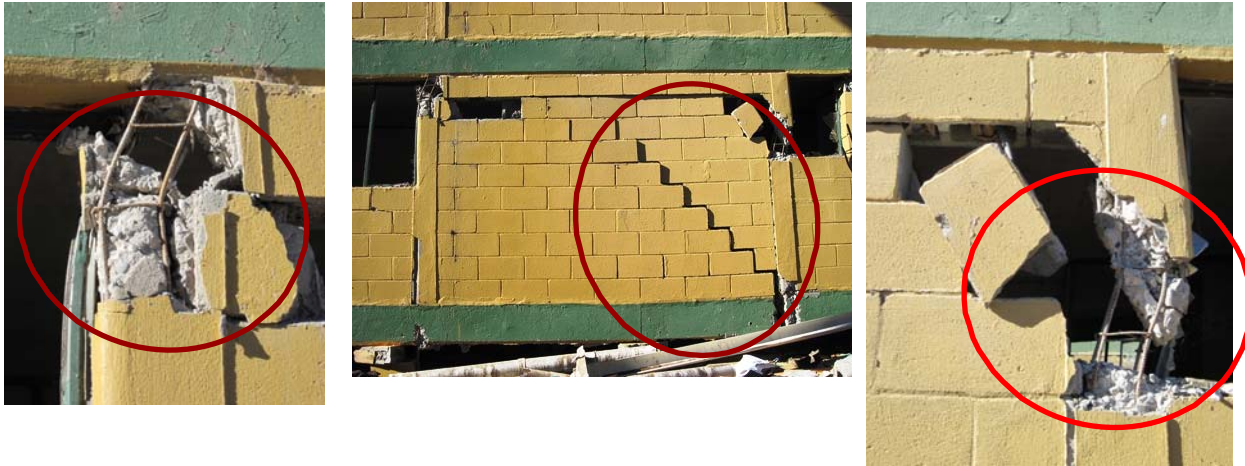
Figure 7 shows details of tie-column damage in a collapsed three-storey building in Santa Cruz. The building lost its first floor and the photo shows damage at the second floor level. The masonry wall panel experienced shear failure, and caused the failure at the ends of adjacent tie-columns.

Figure 7. Failure of RC tie-columns caused by the shear failure of the masonry wall panel.

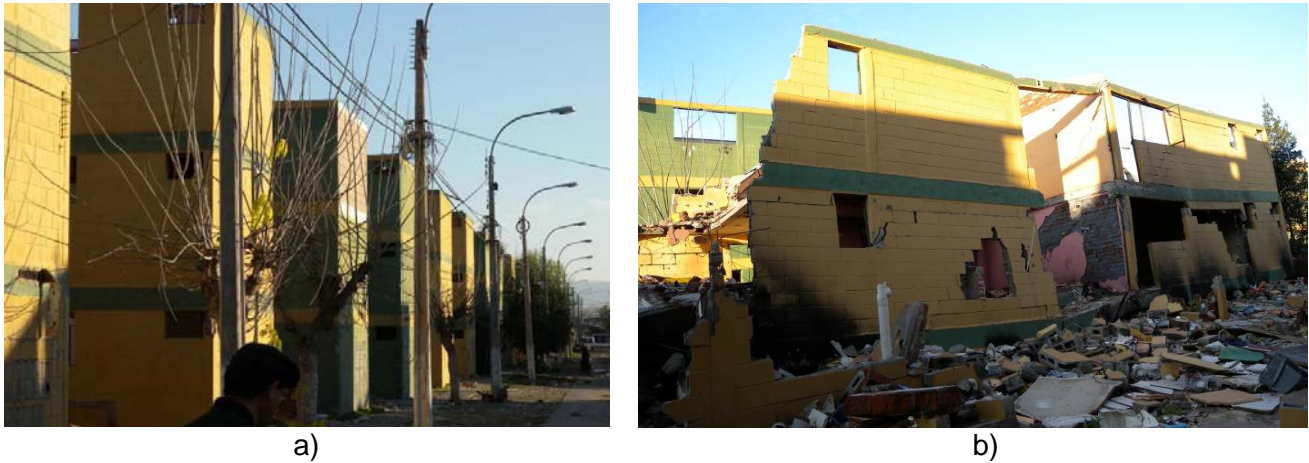
For the first time in Chile, two three-storey confined masonry buildings collapsed in an earthquake after developing a soft story mechanism. One of the collapsed buildings was located in Santa Cruz, where the maximum observed seismic intensity on the MSK scale was 7.5, out of maximum 9.0 reported in the earthquake-affected area (Astroza et al., 2010). The building was a part of the building complex consisting of 32 identical buildings (two rows of 16), as shown in Figure 9 a. Several factors influenced seismic performance of this building and likely led to its collapse, such as inadequate wall density (less than 1 % calculated on a floor basis) combined with low-strength masonry walls, absence of RC tie-columns at the openings, and inadequate size of RC tie-columns. In this building, exterior walls were built using hollow concrete blocks, and the interior ones using hand-made solid clay bricks. Wall thickness was 150 mm and the size of RC tie-columns was 150 by 150 mm. The collapsed building lost its ground floor, as shown in Figure 9 b.

Figure 9. Collapse of a three-story confined masonry building in Santa Cruz: a) building complex, and b) a building that collapsed at the ground floor level.

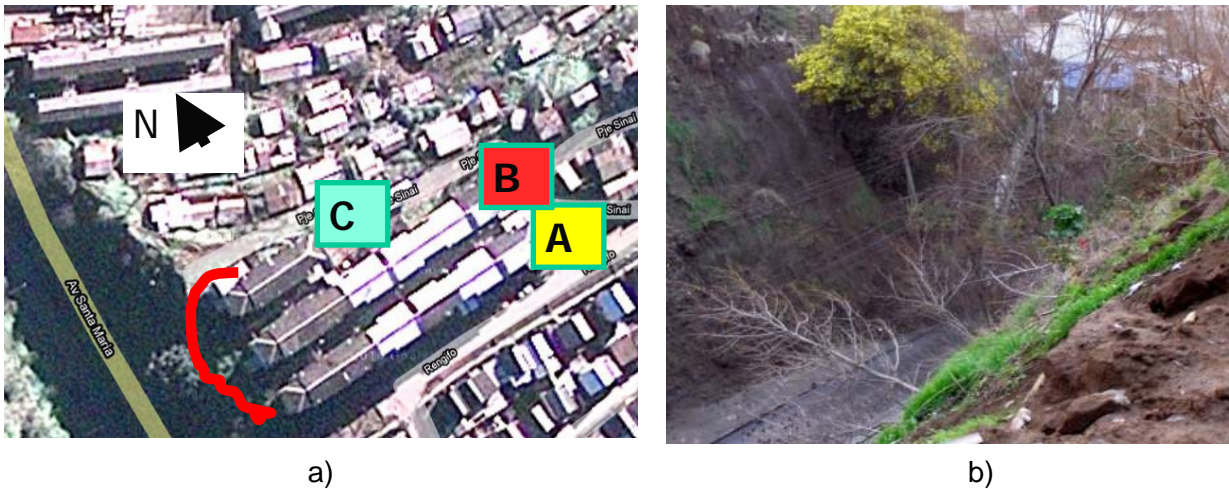
The other building was located in Constitución, a city affected both by the earthquake and the subsequent tsunami. The maximum observed seismic intensity on the MSK scale was 9.0 (significantly higher than Santa Cruz) (Astroza et al., 2010). The collapsed building was a part of a complex which included three buildings (A, B, and C) built on the hill, close to a steep slope, as shown in Figure 10. Building C located closest to the slope (5 m distance on the west side) collapsed, while buildings A and B suffered damages of various extent. It appears that several owner-driven renovations took place before the earthquake - for example, a door opening appears to have been made in a load-bearing masonry wall at the ground floor level of the collapsed building.

Figure 10. Collapse of a three-story confined masonry building in Constitución: a) an aerial view of buildings A, B and C, and b) a steep slope on the west side of the building complex.

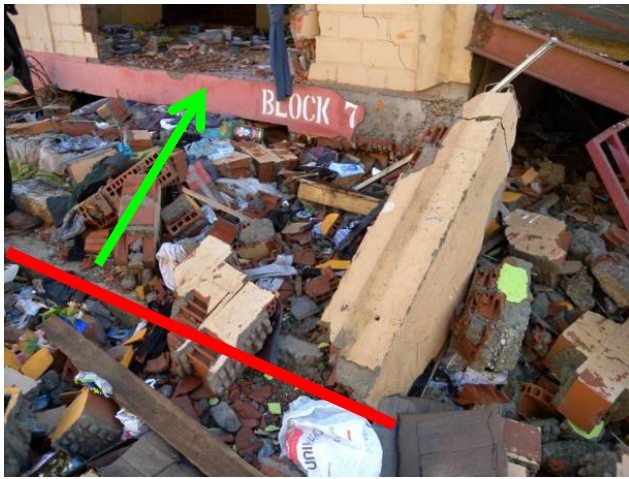
The collapsed building shifted by approximately 1.5 m in the north direction (towards the slope), as shown in Figure 11 a. Note that building B experienced more extensive damage than building A. The damage in all buildings was more pronounced in the north-south direction (transverse direction of the building plan). The collapse was initiated by the shear failure of the transverse walls, which was followed by the out-of-plane failure in the longitudinal walls (horizontal cracks due to out-of-plane seismic effects were observed in the longitudinal wall of building B). The walls were constructed using 140 mm thick hollow clay block units. RC tie-columns had different cross-sectional dimensions depending on the location: length ranged from 140 to 200 mm, and depth was equal to the wall thickness. In addition, a few wide RC columns (700 to 900 mm long and 140 mm wide) lightly reinforced with nominal vertical and horizontal reinforcement were also found in these buildings.

Figure 11. A collapsed three-story confined masonry building in Constitución: a) building C (located closest to the slope) lost the ground floor and shifted by approximately 1.5 m away from the plinth towards north, and b) a typical floor plan for Building C showing the locations of RC tie-columns.

Geotechnical effects have contributed to damage and/or collapse of at least two confined masonry apartment buildings. The collapsed three-storey building in Constitución was described in Section 2.3. Building C located closest to the steep slope collapsed, while buildings A and B suffered damage of various extent. A localized influence of the unrestrained slope boundary and localized variations in sub-surface strata might have generated localized variations of horizontal (and possibly vertical) ground accelerations at the building site (Fannin, 2010). It appears that, before the earthquake,

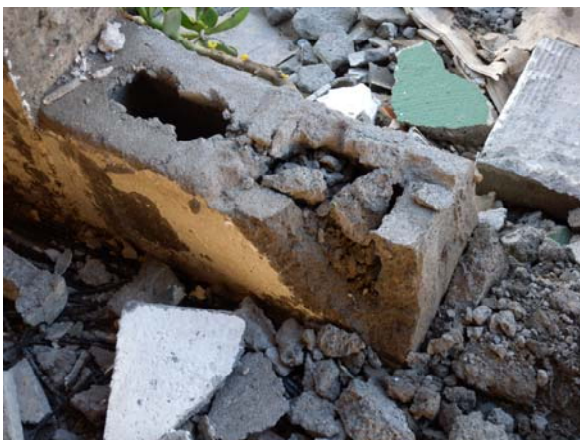
A substandard quality of masonry construction was observed in a few severely damaged buildings. The quality of hollow clay blocks (hollow clay tiles) was generally found to be good. Poor quality of hollow concrete blocks was observed in a few damaged apartment buildings, as shown in Figure 12 a. In some instances, excessively thick mortar bed joints (on the order of 30 mm) were observed in brick masonry walls, as shown in Figure 12 b. Hand-made clay bricks used for wall construction in these cases were characterized by a substantially lower strength compared to machine-made bricks. As a result, it is expected that the compressive and shear strength of such masonry is very low.

Figure 12. Poor quality of masonry construction: a) low-strength concrete blocks, and b) excessively thick mortar bed joints in brick masonry construction.

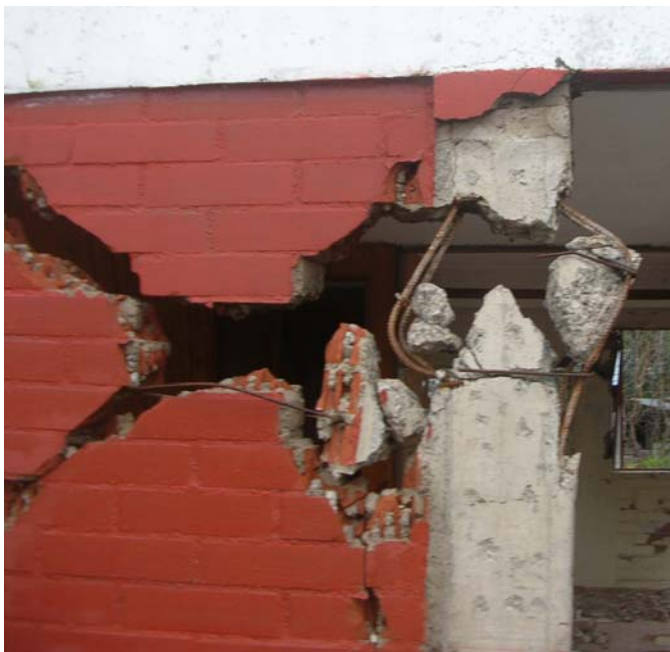
Inadequate confinement at the ends of RC tie-columns was observed in most cases when these regions were exposed due to earthquake damage, as shown in Figure 13 a. According to the NCh 2123, a closer tie spacing of 100 mm is required in tie-column end regions compared to that in the middle portion of the column (200 mm). A typical detail showing tie spacing requirements for end regions is shown in Figure 13 b. This practice was not observed in any of the damaged buildings. A possible reason is the use of prefabricated reinforcement cages with uniform tie spacing up the tie-column height. An enhanced confinement in the end zones of RC tie-columns is expected to prevent a premature buckling when increased axial compression stresses develop in localized areas where masonry is completely disintegrated, as discussed in Section 2.2.

Figure 13. Inadequate confinement in the end zones of RC tie-columns: a) buckling of longitudinal reinforcement (note an excessively large tie spacing), and b) a closer tie spacing prescribed at the ends of RC tie-columns (Blondet, 2005).

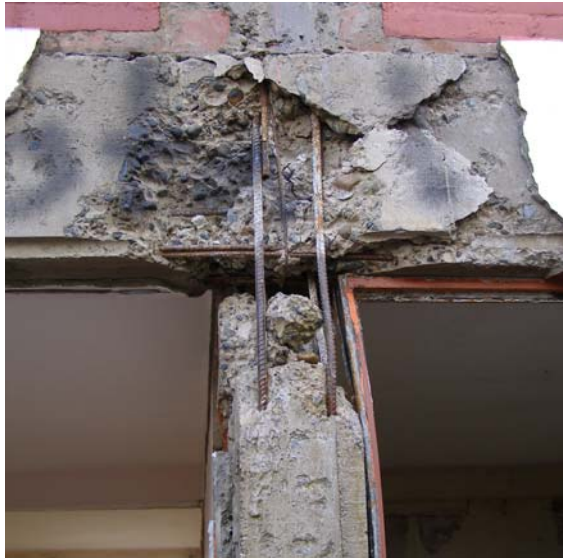
Absence of ties in the joint region was observed in all cases where joints were exposed (see Figure 14 a). This deficiency could cause a shear failure in the joint region, as shown in Figure 14 b. Chilean codes do not contain specific requirements for providing additional ties in the joint region, which could be similar to a detail shown in Figure 14 c.

Figure 14. Absence of confinement in the tie-beam-to-tie-column joint region: a) interior tie-column; b) exterior tie-column, and c) drawing detail showing additional ties in the joint region (Credit: A. San Bartolomé).

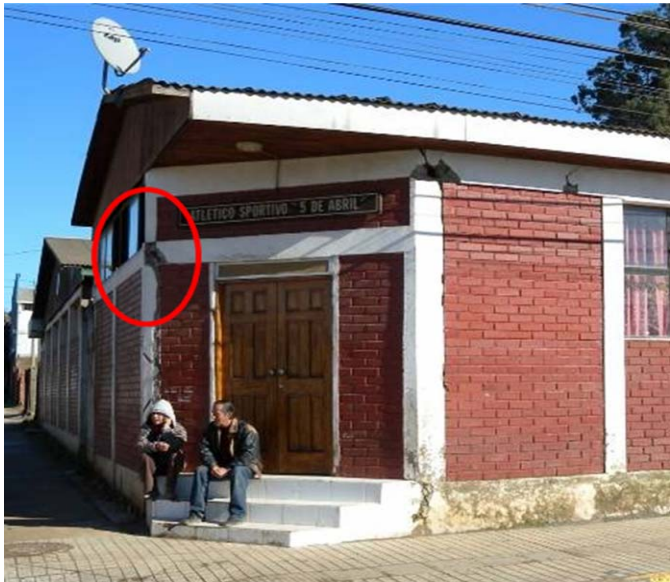
Discontinuous longitudinal reinforcement at the RC tie-beam intersections is shown in Figure 15 a and b. This is contrary to Chilean detailing practice for this location, as illustrated by a drawing detail shown in Figure 15 c. It should be noted that reinforcement cages for tie-beams and tie-columns are often assembled off the building site, however additional “continuity reinforcement” should be provided once the cages are placed in the final position.

Figure 15. Inadequate anchorage of tie-beam reinforcement: a) typical “corner” building; b) tie-beam intersection showing a discontinuity in tie-beam reinforcement, and c) a drawing detail showing “continuity reinforcement” at the intersection (plan view) – for a different building.

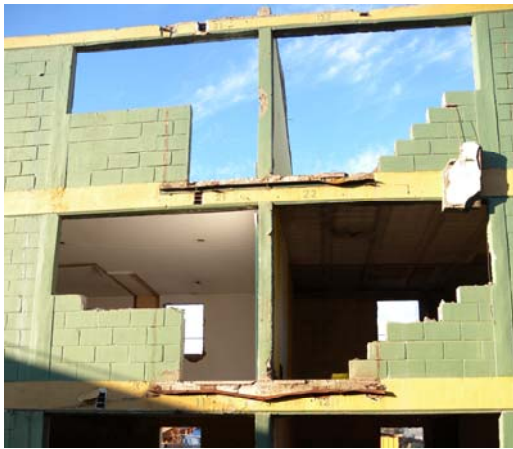
Absence of RC confining elements (tie-columns) at openings was observed in several buildings, as shown in Figure 16 a. This resulted in more extensive damage of masonry piers between the openings, and is contrary to the NCh 2123 requirements and recommendations of other design documents (e.g. EERI, 2010), as illustrated in Figure 16 b. Presence of RC tie-columns at openings enables the development of compressive struts in masonry wall panels. This is the key mechanism for lateral load transfer in confined masonry walls. Masonry wall panels without RC tie-columns at both ends are not considered to be confined, and are not to be considered in wall density calculations (EERI, 2010).

Figure 16. RC confining elements at openings: a) absence of confining elements, and b) confined openings (EERI 2010).

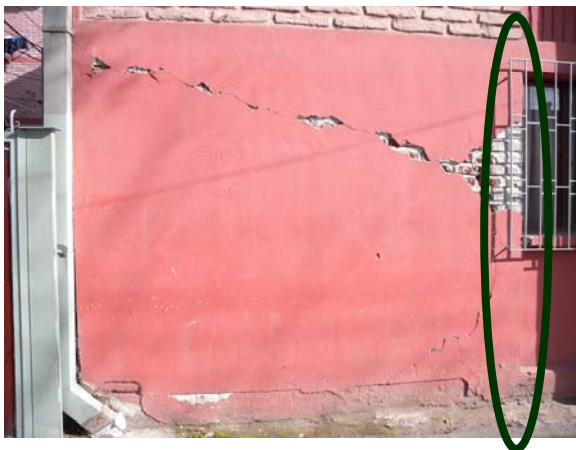
The effect of confinement at the ends of openings can be observed on an example of two apartment buildings located in Santiago. The building shown in Figure 17 a had RC tie-columns at the ends of the openings (note the concrete in the tie-column at the right was formed to mimic brick masonry appearance). The building shown in Figure 17 b had RC tie-column in the middle of the pier. The first building experienced moderate cracking, while the other building experienced severe cracking in almost all piers at the first storey level. Both buildings survived the earthquake and were inhabited at the time of the visit, in spite of apparent damage.

Figure 17. In-plane shear cracking of piers in brick masonry walls: a) a confined masonry panel with RC tie-columns at both ends (note RC tie-column highlighted with a black ellipse), and b) unconfined opening (note RC tie-column at the middle of the pier highlighted with a red ellipse).

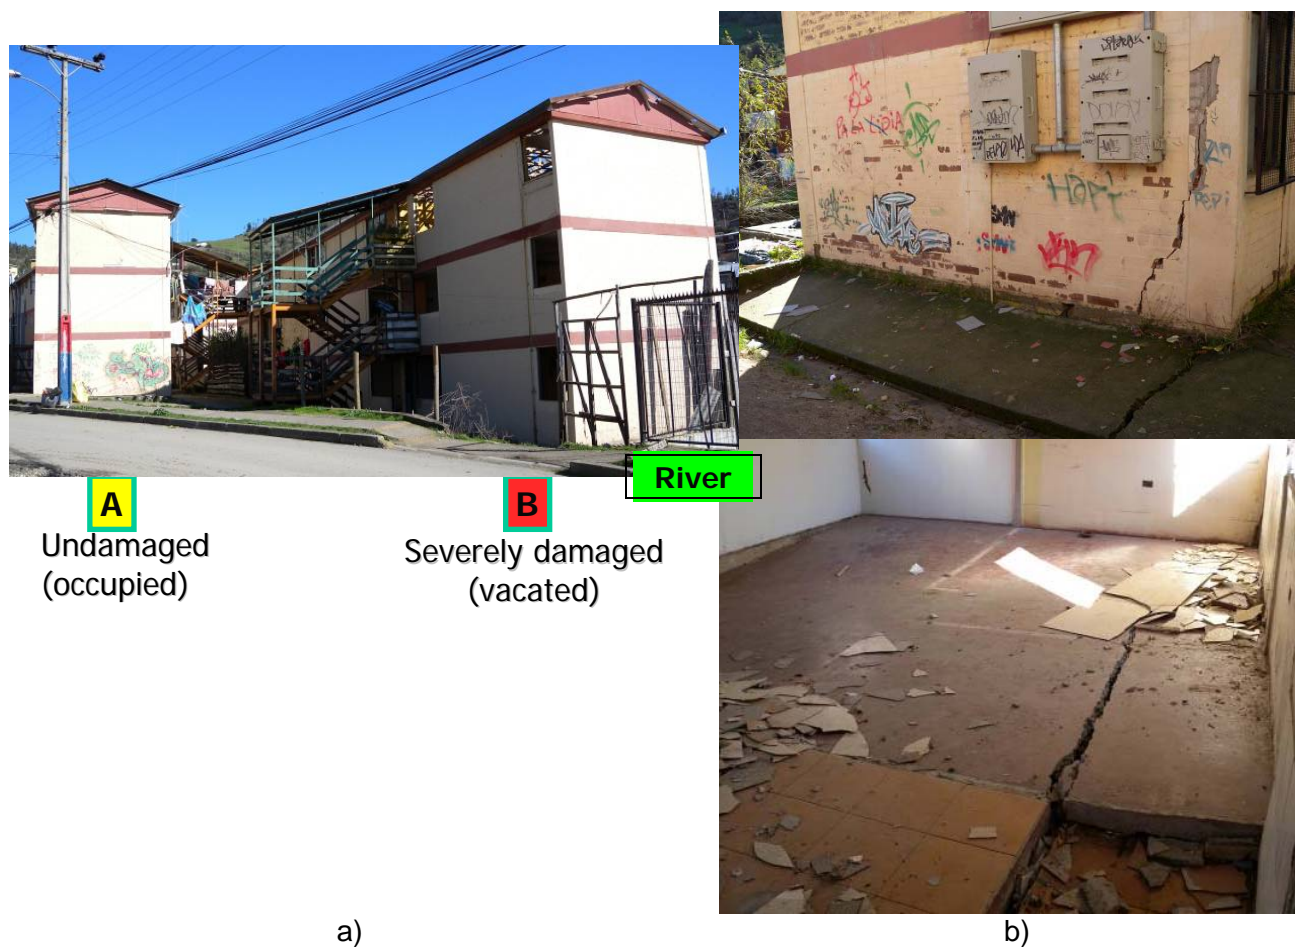
There was another building site in Constitución where geotechnical issues likely caused severe damage in confined masonry buildings. A complex of several three-storey buildings called Centinela was built in 1992 (750 apartments in total). The buildings were built on a moderate slope, in the proximity of a creek. All buildings, except for the one located closest to the creek (building B), remained undamaged and were inhabited at the time of the visit. Building B experienced severe damage, in the form of cracking in the walls and also floors at the ground floor level. Note that an identical building complex in other part of the city remained undamaged. These buildings were government-built (social housing), and construction quality issues were reported before the earthquake.

Figure 18. A building in Constitución experienced severe damage: a) building B located closest to the creek located on the right side of the building, and b) extensive exterior and interior damage in the building.
