Performance of Confined Masonry Buildings in the February 27, 2010 Chile Earthquake

Svetlana Brzev, Maximiliano Astroza and Maria Ofelia Moroni Yadlin

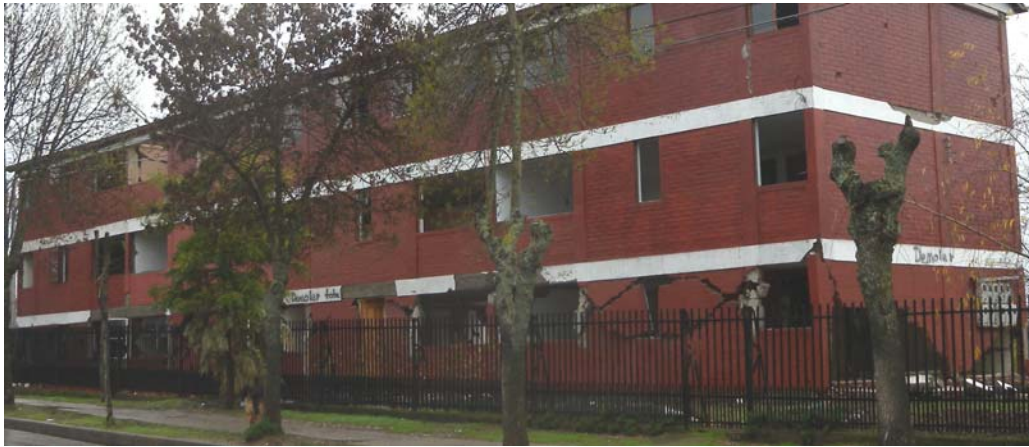
The most common damage pattern observed in masonry walls was in-plane shear cracking. This type of damage was mostly observed at the bottom floor level of three- and four-storey buildings, as shown in Figure 4 a and b (note that the masonry walls were not confined at the openings). In a very few cases, this damage pattern was observed in single-family dwellings, again at the first floor level of a

Figure 4. In-plane shear failure of masonry walls: a) a three-storey building in Cauquenes experienced severe damage at the ground floor level; b) a closer look into damaged walls in the same building (note absence of confining elements at openings), and c) shear cracking in a brick masonry wall of a two-storey single family house in Talca.

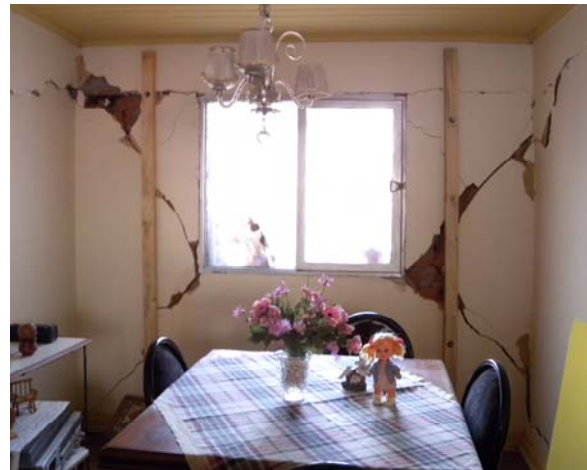
c)

two-storey building, as shown in Figure 4 c. Shear cracking was observed in walls built using all types of masonry units, including hollow clay tiles, clay bricks, and concrete blocks. Note that the walls in the building shown in Figure 4 a and b were built using hollow clay blocks, while the wall shown in Figure 4 c was built using clay bricks.

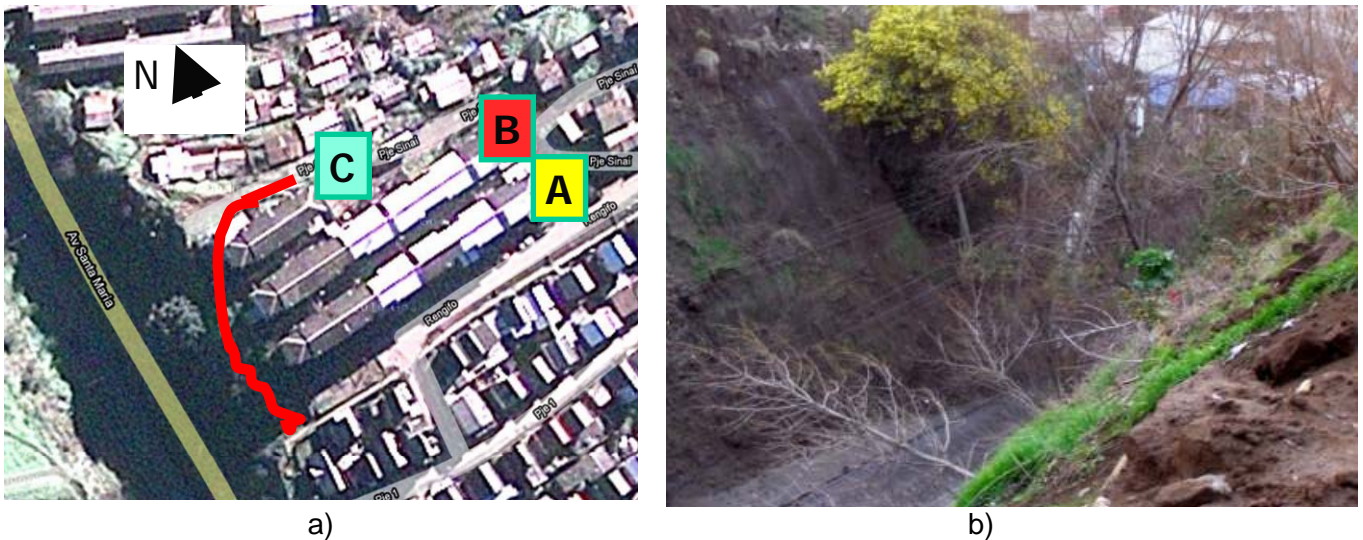
The other building was located in Constitución, a city affected both by the earthquake and the subsequent tsunami. The maximum observed seismic intensity on the MSK scale was 9.0 (significantly higher than Santa Cruz) (Astroza et al., 2010). The collapsed building was a part of a complex which included three buildings (A, B, and C) built on the hill, close to a steep slope on the west and north side, as shown in Figure 10. Building C located closest to the slope (5 m distance on the west and north side) collapsed, while buildings A and B suffered damages of various extent. It appears that several owner-driven renovations took place before the earthquake - for example, a door opening appears to have been made in a load-bearing masonry wall at the second floor level of the collapsed building.

Figure 10. Collapse of a three-story confined masonry building in Constitución: a) an aerial view of buildings A, B and C, and b) a steep slope on the west side of the building complex.

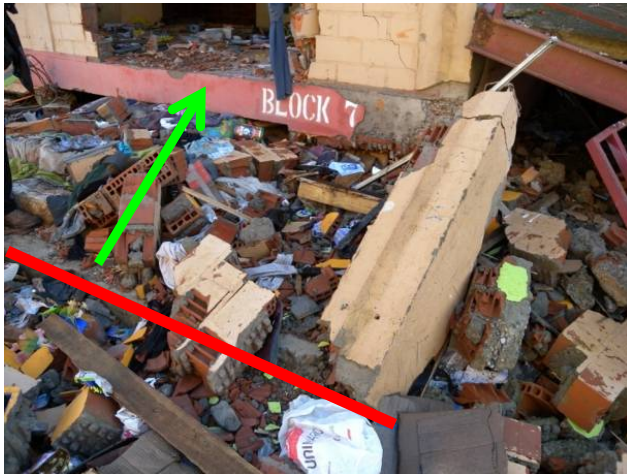
The collapsed building shifted by approximately 1.5 m in the north direction (towards the slope), as shown in Figure 11 a. Note that building B experienced more extensive damage than building A. The damage in all buildings was more pronounced in the north-south direction (transverse direction of the building plan). The collapse was initiated by the shear failure of the transverse walls, which was followed by the out-of-plane failure in the longitudinal walls (horizontal cracks due to out-of-plane seismic effects were observed in the longitudinal wall of building B). The walls were constructed using 140 mm thick hollow clay block units. RC tie-columns had different cross-sectional dimensions

depending on the location: length ranged from 140 to 200 mm, and depth was equal to the wall thickness. In addition, a few wide RC columns (700 to 900 mm long and 140 mm wide) lightly reinforced with nominal vertical and horizontal reinforcement were also found in these buildings. These wide columns replaced tie-columns at some locations (this practice is followed in medium-rise confined masonry construction in Chile). A typical floor plan is shown in Figure 11 b. It is believed that the building location and geotechnical effects, in addition to a low wall density in the north-south direction (less than 1 % calculated on a floor basis), were the key factors contributing to the collapse.

Figure 11. A collapsed three-story confined masonry building in Constitución: a) building C (located closest to the slope) lost the ground floor and shifted by approximately 1.5 m away from the plinth towards north, and b) a typical floor plan for Building C showing the locations of RC tie-columns.

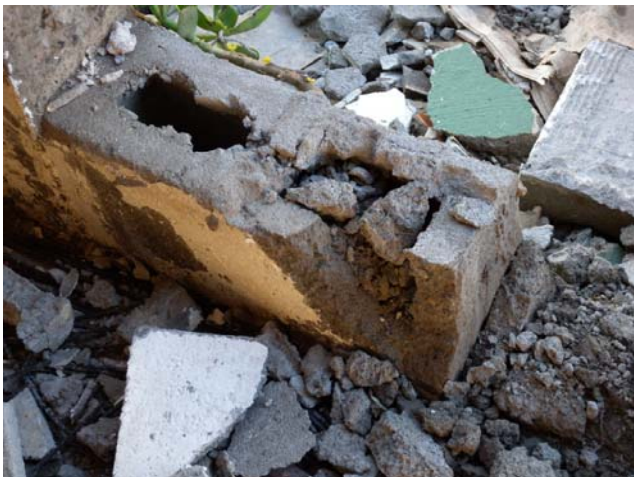
A substandard quality of masonry construction was observed in a few severely damaged buildings. The quality of hollow clay blocks (hollow clay tiles) was generally found to be good. Poor quality of hollow concrete blocks was observed in a few damaged apartment buildings, as shown in Figure 12 a. In some instances, excessively thick mortar bed joints (on the order of 30 mm) were observed in brick masonry walls, as shown in Figure 12 b. Hand-made clay bricks used for wall construction in these cases were characterized by a substantially lower strength compared to machine-made bricks.

Figure 12. Poor quality of masonry construction: a) low-strength concrete blocks, and b) excessively thick mortar bed joints in brick masonry construction.

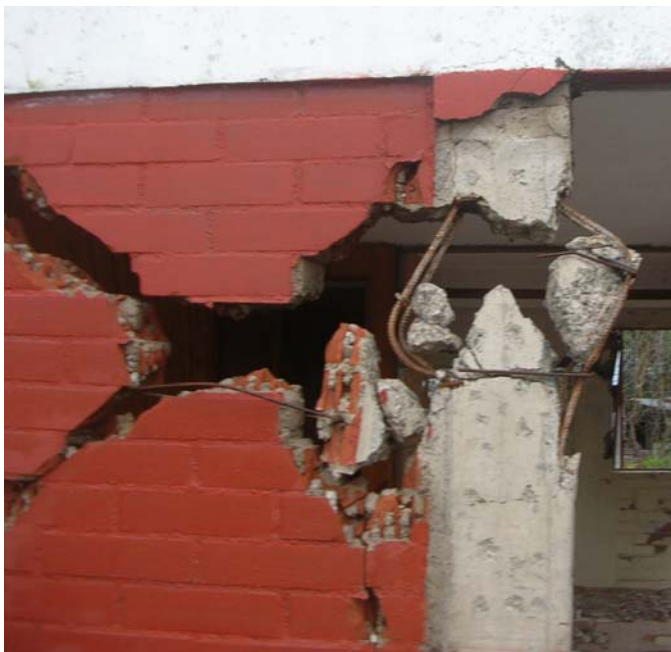
Inadequate amount of transverse reinforcement at the ends of RC tie-columns was observed in most cases when these regions were exposed due to earthquake damage, as shown in Figure 13 a. According to the NCh 2123, a closer tie spacing of 100 mm is required in tie-column end regions compared to that in the middle portion of the column (200 mm). A typical detail showing tie spacing requirements for end regions is shown in Figure 13 b. This practice was not observed in any of the damaged buildings. A possible reason is the use of prefabricated reinforcement cages with uniform tie spacing up the tie-column height. Transverse reinforcement in the end zones of RC tie-columns is expected to prevent shear failure and buckling of longitudinal reinforcement in localized areas where masonry is completely disintegrated, as discussed in Section 2.2.

Figure 13. Inadequate confinement in the end zones of RC tie-columns: a) shear failure and buckling of longitudinal reinforcement (note an excessively large tie spacing), and b) a closer tie spacing prescribed at the ends of RC tie-columns (Blondet, 2005).

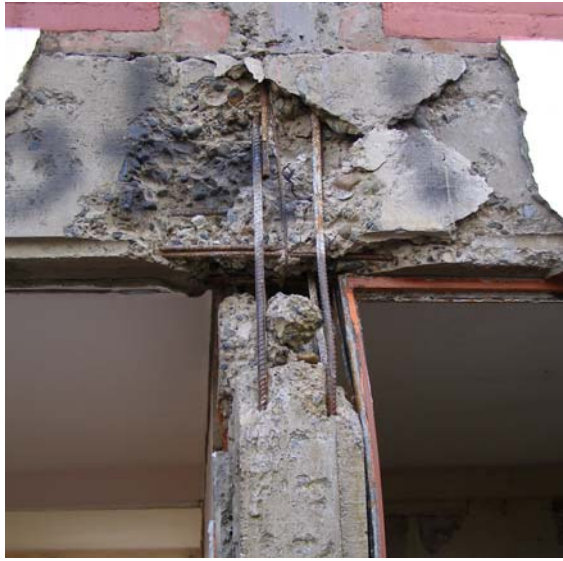
Absence of ties in the joint region was observed in all cases where joints were exposed (see Figure 14 a). This deficiency could cause a shear failure in the joint region, as shown in Figure 14 b. Chilean codes do not contain specific requirements for providing additional ties in the joint region, such as shown in Figure 14 c.

Figure 14. Absence of confinement in the tie-beam-to-tie-column joint region: a) interior tie-column; b) exterior tie-column, and c) drawing detail showing how additional ties in the joint region could be accommodated (Credit: A. San Bartolomé).

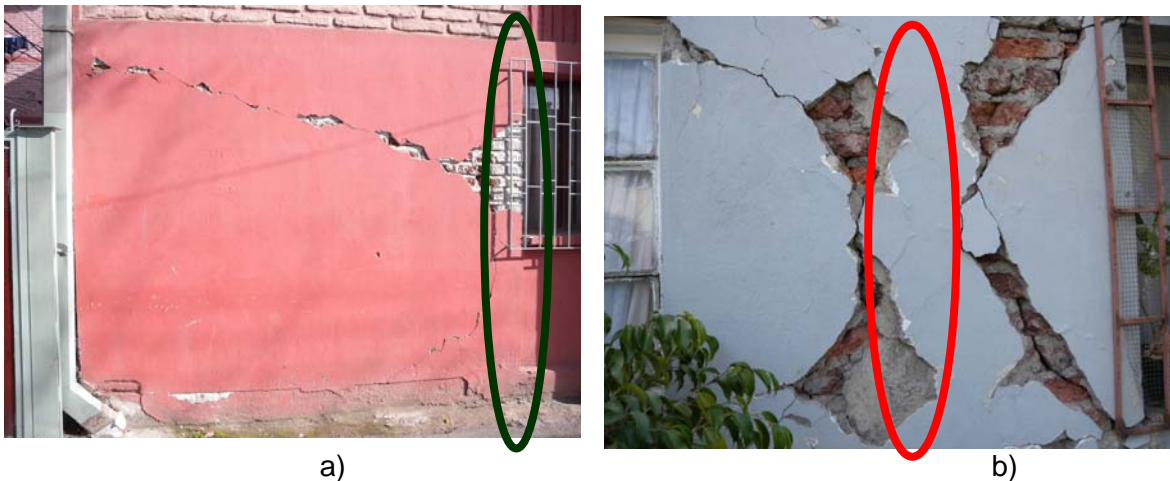
Absence of RC confining elements (tie-columns) at openings was observed in several buildings; this resulted in more extensive damage of masonry piers between the openings. The effect of confinement at the ends of openings can be observed on an example of two apartment buildings located in Santiago. The building shown in Figure 17 a had RC tie-columns at the ends of the openings (note the concrete in the tie-column at the right was formed to mimic brick masonry appearance). The building shown in Figure 17 b had RC tie-column in the middle of the pier (instead at the ends). The first building experienced moderate cracking, while the other building experienced severe cracking in almost all piers at the first storey level. Both buildings survived the earthquake and were inhabited at the time of the visit, in spite of apparent damage.

Figure 17. In-plane shear cracking of piers in brick masonry walls: a) a confined masonry panel with RC tie-columns at both ends (note RC tie-column highlighted with a black ellipse), and b) an unconfined panel (note RC tie-column at the middle of the pier highlighted with a red ellipse).

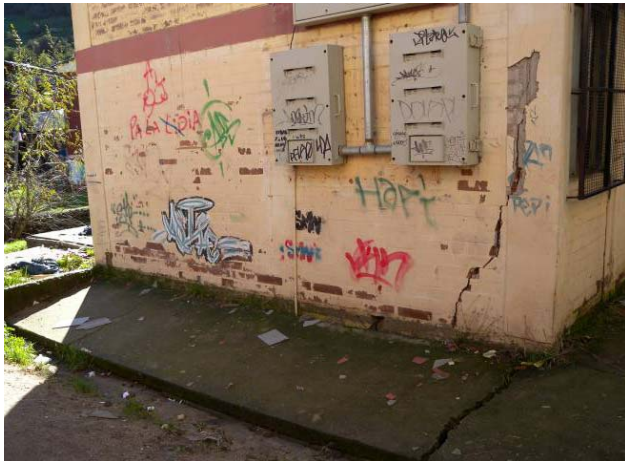
was built in 1992 (750 apartments in total). The buildings were built on a moderate slope, in the proximity of a creek. All buildings, except for the one located closest to the creek, remained undamaged and were inhabited at the time of the visit. The building located closest to the creek was abandoned due to severe damage, in the form of cracking in the walls and floors at the ground floor level, as shown in Figure 18. Note that an identical building complex in other part of the city remained undamaged. These buildings were government-built (social housing), and construction quality issues were reported before the earthquake.

Figure 18. A building in Constitución experienced severe damage: a) extensive exterior damage in the building located closest to the creek located on the left side of the building, and b) extensive floor damage inside the building.
