CONFINED MASONRY BUILDINGS: THE CHILEAN EXPERIENCE

M. Astroza⁽¹⁾, F. Andrade⁽²⁾, M.O. Moroni⁽³⁾

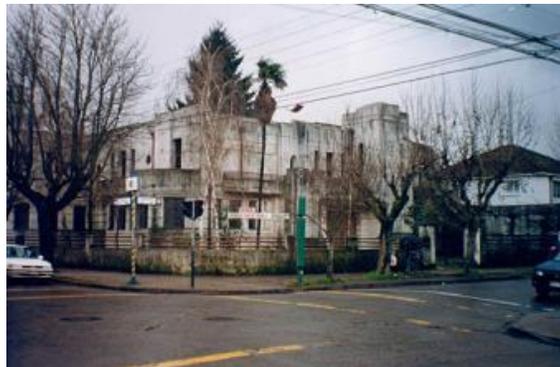
Fig. 3 - Old confined masonry house currently in use in Chillan [11]

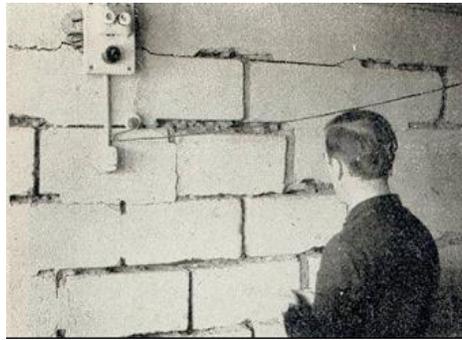
1965 La Ligua earthquake. This earthquake corresponds to an intraplate earthquake of intermediate depth of magnitude 7.1 with the epicenter about 140 km from Santiago [18]. Again, the effects of the earthquake were severe in adobe and unreinforced masonry houses, the latter behaving particularly bad, even though most of them were reinforced with concrete tie-beams at the top of the walls forming a horizontal grid. About 21,000 masonry houses collapsed and 71,000 had to be repaired. This was an unexpected behavior for one-story masonry buildings; although most of them did not have tie-columns at ends of masonry panels and at wall intersections. The results were especially bad in houses made of hollow concrete blocks, units that started to be used in those years. Typical patterns of damage were: in-plane shear failure, cracks by out-of-plane flexure, vertical cracks by lack of bond between masonry and concrete elements, damages in beam-column joints and vertical cracking at wall intersections. Some of the observed damage is shown in Fig. 4.

Fig. 4 - Observed damage in concrete block masonry panel during 1965 La Ligua earthquake

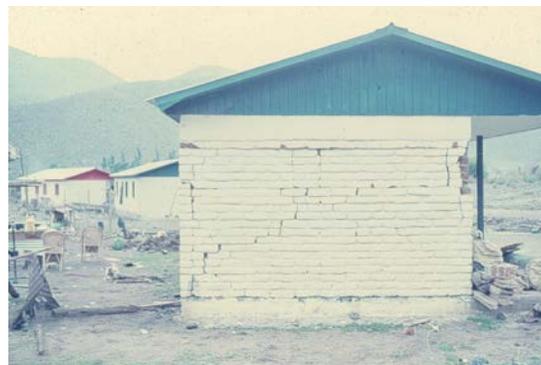
1971 Papudo earthquake. This event was an interplate earthquake of magnitude 7.5, which hit mainly the Region V of Chile, affecting practically the same zone of the 1965 La Ligua earthquake. Again, masonry houses were damaged and of particular interest was the case of the destruction of about 1,000 houses located in the valley of the Choapa River (see Fig. 5). The walls of these one-story houses were built with hand-made clay bricks, reinforced at the top of the walls with RC beams and with some vertical tensile steel bars placed at the wall intersections, within holes perforated in the bricks. The effects of poor quality of soils [19] and inappropriate design of the foundations made the damage more severe.

Fig. 5 - Observed damage during 1971 Papudo earthquake

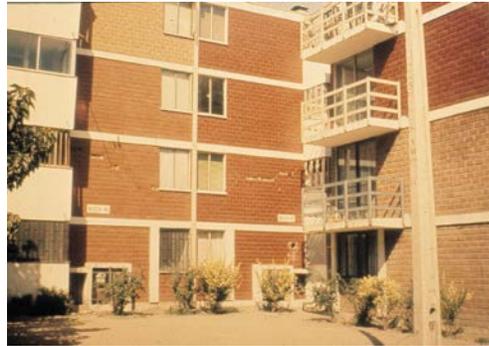
Most of the masonry buildings with severe damage were three- or four-story high and they did not have tie-columns at one wall end or around window openings. In many cases, the only reinforcement was one steel vertical bar located inside of a hollow unit (see Fig. 6), which did not satisfy the minimum recommended by the reinforced masonry code UBC-1979. This occurred because prior to 1986, there was no Chilean design code for reinforced and confined masonry buildings.

Fig. 6 - Observed damage during 1985 Llolleo earthquake in the second floor of building located in Santiago

- Diagonal stepped bed-joint cracking in the masonry panel due to a bad bond between mortar and units.
- Propagation of panel diagonal cracks into top and bottom of tie-columns.
- Crushing of hollow masonry units with large percentage of voids and thin shells and webs in the most stressed zones of the masonry panel.
- Horizontal cracking at the joint between masonry wall and the RC floor slab or foundation
- Cracking in walls due to out-of-the-plane seismic loads when the masonry panels were not properly confined or the separation between tie-columns was too large.
- Cracking, crushing and disintegration of concrete at the tie-beam/tie-column connections when reinforcement detailing was inappropriate.
- Inadequate quality of masonry materials (mortar, grout) and poor workmanship.

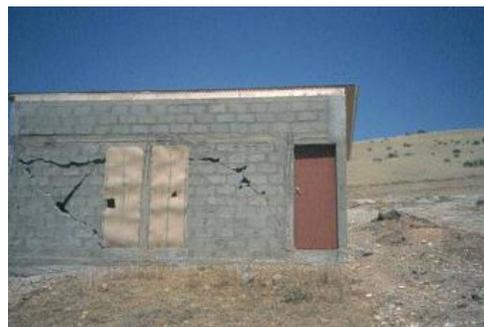
1997 Punitaqui earthquake: This intermediate depth intraplate earthquake, magnitude $M_w = 7.1$ [20] caused damage in the IV Region, especially in adobe houses. Damage to masonry houses was reduced in number and severity. According to information provided by the Regional Municipality of Region IV [21], from a total of 839 masonry houses, 11.4% were destroyed, 26.1% had risk of collapse, 11% had moderate damage, and 51.5% had light or no damage. This statistic does not distinguish the type of reinforcement and relates mainly to hybrid type construction. A damaged one-story house with little reinforcement is shown in Fig. 7.

Considering the magnitude of the event, the amount of damage was higher than expected due to the mechanism that generated the earthquake, confirming what was observed earlier in earthquakes of this type, i.e., the 1939 Chillán and 1965 La Ligua earthquakes.

Fig. 7 - One-story house damaged during 1997 Punitaqui earthquake

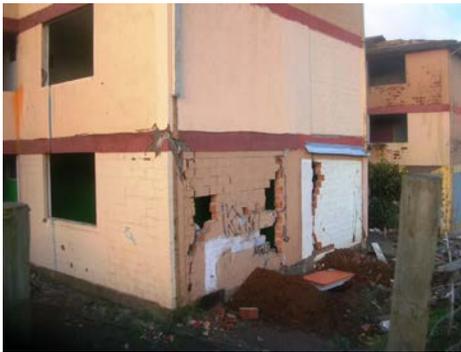
Constitución

A few medium-rise confined masonry buildings of older vintages suffered moderate and repairable damage. For example, diagonal cracking in masonry walls was observed in four-story buildings in Huemul II complex, located in Santiago and built in 1947; the same damage occurred in the 1985 Lolleo earthquake and was subsequently repaired [22]. Similar damage patterns were observed in the complex of four-story buildings called Roto Chileno (built in Santiago in 1960) and in the Costanera Norte complex, built in Talca in 1956. The masonry walls of these old buildings were built using hand-made solid clay bricks and a low-strength mortar (cement:lime:sand mix ratio 1:1:6). In addition, RC tie-columns were provided only at wall intersections but not around the openings, thus these old buildings can be considered as "partially confined". Examples of severe damaged partially confined masonry buildings are shown in Fig. 8.

Fig. 8 - Observed damage during 2010 Maule earthquake
