## SEISMIC EVALUATION AND RETROFIT FOR REDUCING THE VULNERABILITY OF HOUSING IN COLOMBIA: DEVELOPMENT AND IMPLEMENTATION

D. Nacif Hartley<sup>(1)</sup>, M. L. Blaisdell<sup>(2)</sup>, J. Caballero<sup>(3)</sup>, E. Hausler Strand<sup>(4)</sup>

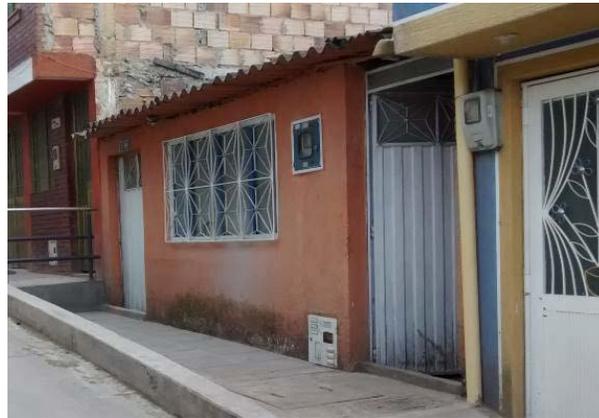
Fig. 3 – Façade of 1-story example house, Usme

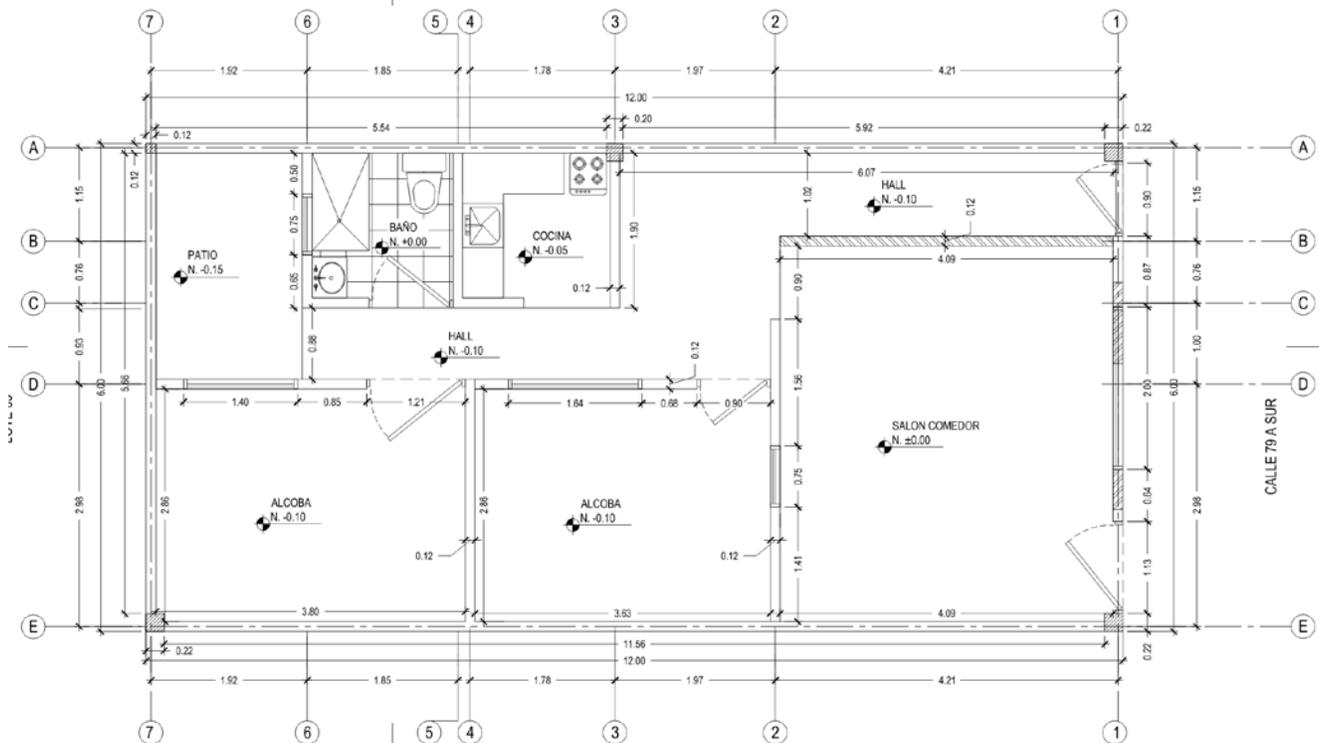
Fig. 4 – Existing wall plan configuration, Usme house.

Based on the checklist, several deficiencies were identified in the construction system of the example house. For load path, the checklist sets a maximum distance between adjacent parallel walls at 4 meters in order to control out-of-plane wall failure of the perpendicular walls, as well as ensure sufficient lateral resistance. This house had several walls that spanned further than 4 meters, without intermediate support, and was therefore found to be non-conforming. Additionally, the weight of the building, considering the existing plaster wall finished exceeded the base value, which would trigger an increase in the wall area percentage required in the following checklist section.

The configuration of the example house met the checklist requirements for adjacent buildings and, as a one-story structure, was not applicable for the checklist item regarding vertical continuity. However, the example house did not meet the required check for torsion: that all exterior walls have shear walls on grid, or within a quarter of the building length from the exterior. The front wall of the house did not have a length of continuous masonry wall long enough to qualify as a lateral force-resisting wall and the next interior transverse shear wall was not within the quarter-length requirement. Refer to the existing plan in Fig. 4.

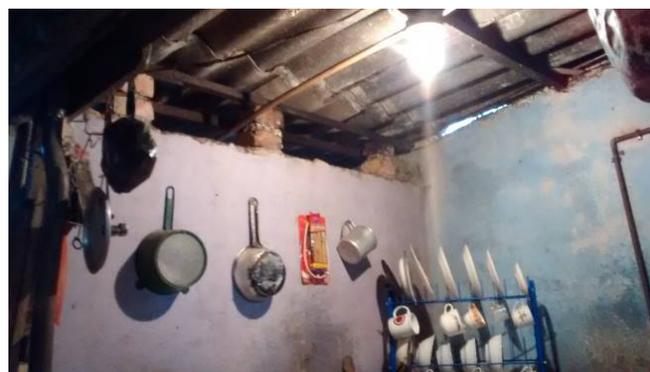
The example house did not conform to any of the checks regarding the masonry wall construction. The lack of a reinforced concrete beam at the top of the wall (See Fig. 5) was identified as a deficiency itself and also implied a deficiency for the vertical confinement of the wall. Masonry walls are required to be vertically confined by a flush reinforced concrete top beam or slab (with no gap between the masonry and concrete elements). A beam at the top of the wall is required for light-weight roof conditions in order to brace the top of the wall and distribute the out-of-plane load to the adjacent perpendicular walls (the light-weight roofs do not act as an effective diaphragm for this). In buildings with slab roofs, the slab acts as the diaphragm for this out-of-plane support.

Fig. 5 – Masonry wall without top beam

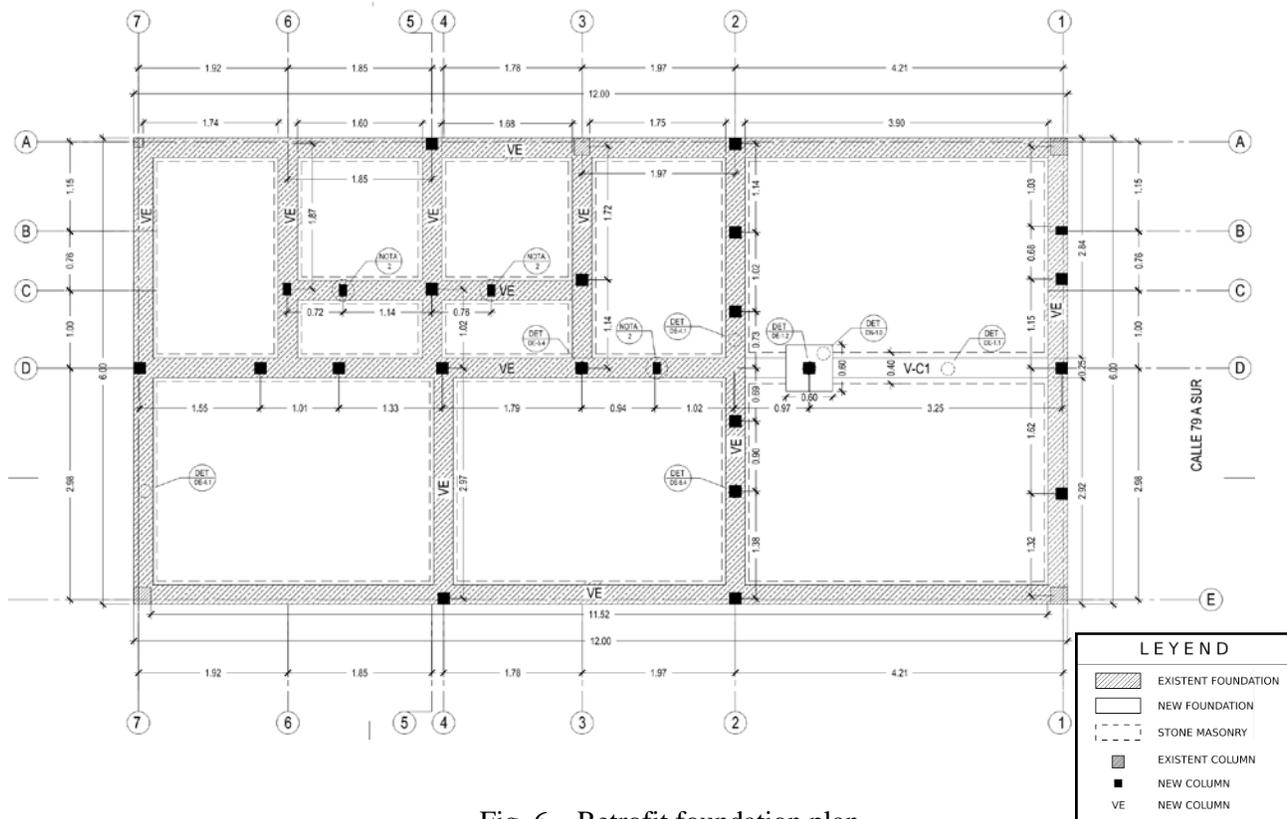
Fig. 6 – Retrofit foundation plan

In order to increase the ductility and strength of the structure, the retrofit design for the example house includes adding confining elements, such as vertical ties and top beams, to many of the existing walls where they were not previously present. A summary of the deficiencies and the solutions applied in the retrofit design is shown in Table 5 and the resulting retrofit floor plan is presented in Fig. 7. As it is shown in Fig. 6, every new vertical tie is connected to the existing foundation, providing an anchor for tension in the confining tie under lateral loading in the wall panel.

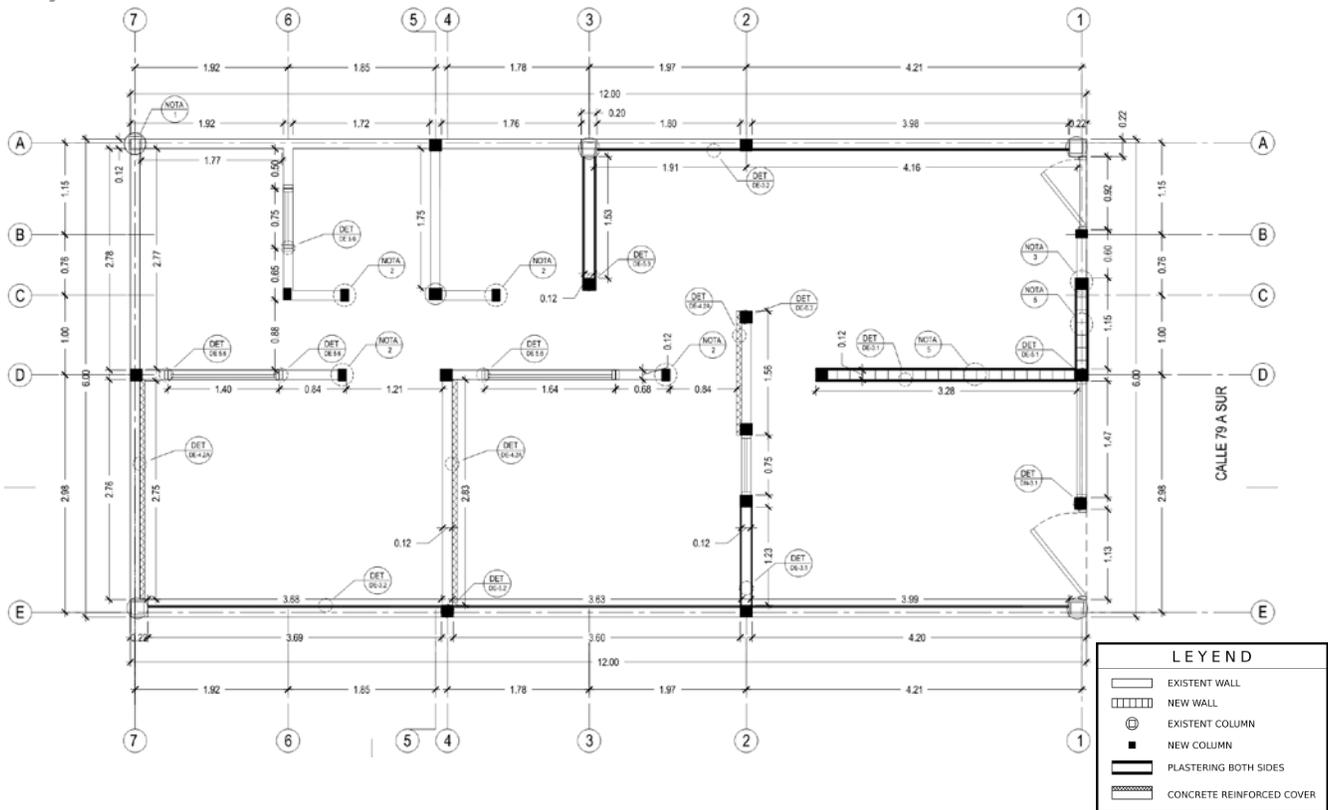
Fig. 7 – Retrofit wall plan

Deficiency	Retrofit solution taken
Spacing between parallel walls greater than 4.0m	New walls were added to the structure to reduce spans below 4m.
Seismically heavier structure compared to the standard (plastered walls)	The additional weight was incorporated into the design by taking a proper weight factor in determining the required WAP.
The masonry is not tight to the confining elements.	New concrete columns were added and they will be poured against the indented wall edges, and a new top beam was added.
Windows and doors do not have reinforcement on their edges or lintels.	New concrete elements were added: at the windows vertical ties were added to each side, vertical tie columns were added at each side of the door openings, and the openings were extended to the top beam above.
Absence of continuous top beam on all walls.	Top beams were added on every wall which are continuous and interconnected.

Wall area percentage is insufficient in both directions.	Different retrofitting technics were considered, such as the addition of new walls, new confining elements for existing walls, new structural plaster, and reinforced concrete overlays. See Table 6.
Torsional problem due to insufficient lateral resistance at the front of the building.	A confined masonry shear wall was added to the front wall.
