DESIGN and CONSTRUCTION of CONFINED MASONRY HOUSES in INDONESIA: CHALLENGES, PERFORMANCE in EARTHQUAKES, and NEED FOR FUTURE RESEARCH

BACKGROUND AND PREVALENCE OF CONFINED MASONRY IN INDONESIA

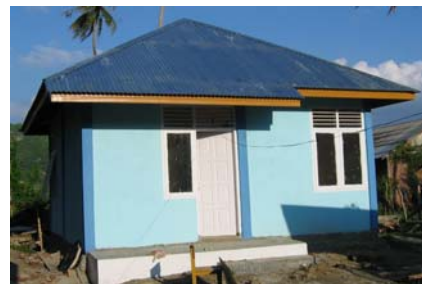
Fig. 1. Build Change Pilot Project House, Hipped Roof (Owner: Rusdi Razali).

Roof. Roof was made of timber trusses covered by corrugated galvanized sheeting. Both hipped (Fig. 1) and pitched (Fig. 7) roofs covers with CGI sheets were already common. Timber gables were used for pitched roofs. Trusses were tied down with U-shaped steel plates. The tie downs were needed to prevent uplift in strong winds, and intended as an alternative the common practice of wrapping the tie column bars around the trusses, leaving them exposed to corrosion.

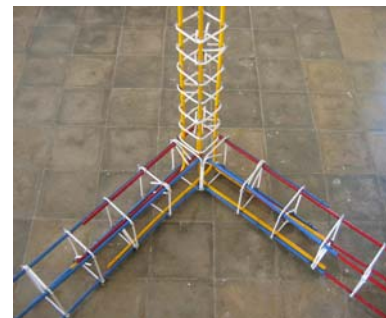
Fig. 3. Bond Beam-Tie Column Connection Model. Note it has been suggested that to strengthen the interior corner, the interior long bars should pass through the joint and tie to the external long bars.

- Specified hook length, hook rotation, and joint detailing on the drawings. It was not common practice to call out these details on engineering drawings used in Aceh. See Figs. 3 and 4.

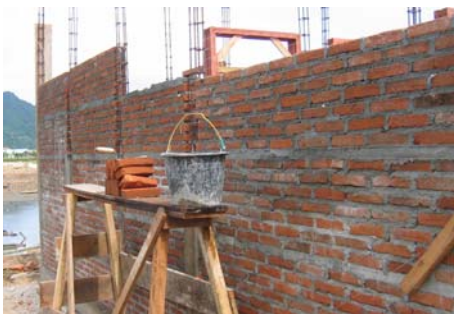
Fig. 6. Wall with Horizontal Reinforcement.

We opted for the combined solution of additional vertical confining elements adjacent to all large openings, and horizontal steel reinforcement in the wall. The reinforcement detail (Fig. 5 and 6) was also assumed to increase the in-plane strength of the wall. We shifted the openings to the corners to and locations of major columns so that only one additional tie column would be needed (rather than two, if the openings remain centered). All walls were finished with cement-based plaster and painted.

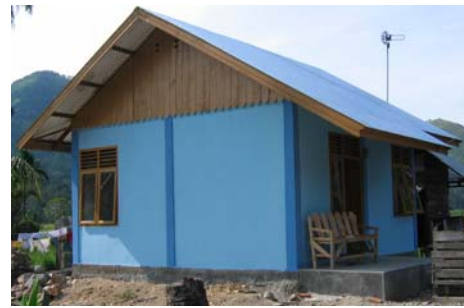
Fig. 7. Build Change Pilot Project House, Pitched Roof. Owner: Ruslan AB.

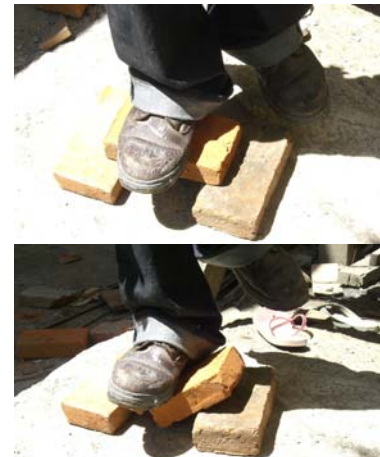
Fig. 8. Three point bending test for brick strength, use average size Indonesian male, no bouncing

Bricks. Fired clay bricks are widely available in Sumatra. Soil is mixed by buffalo, machine, or by hand; bricks are hand-molded and fired in open kilns using wood or rice husks as fuel. Brick quality (strength, consistency of size and shape) was variable. We did a quick review of the brick manufacturing process at several kilns to determine which vendors to purchase from. The type of clay and the firing process had the biggest impact on brick quality. Many brick producers had access only to a source of clay that was prone to warping and shrinking during firing. The length of burn, fuel used in burning, and the location of the brick in the kiln also strongly influenced its properties. Bricks at the top of the kiln were rarely completely fired, and would erode or crumble in the rain. We used simple three-point bending tests¹⁰ (see Fig. 8) and the following checks to evaluate brick strength in the field.

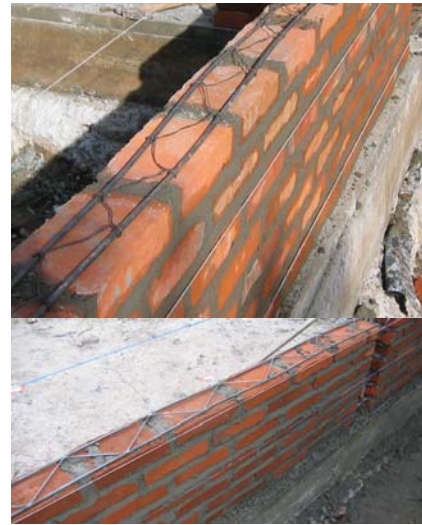
Fig. 9. Horizontal reinforcement fabricated on-site with binding wire (top) and prefabricated at welding shop (bottom).

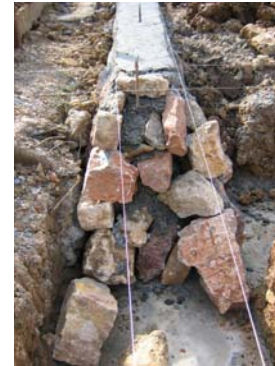
Fig. 11. Poorly built stone masonry strip footing. Note gaps between stones, stones standing on end.

Stone Masonry Strip Footing Construction: At the base of the excavation, we used a weak screed layer instead of the more common layer of loose cobbles. The challenge with the stone masonry strip footing was to ensure the builders filled all the gaps between the stones with mortar, laid the stones down rather than standing them up, and used long stones at corners and t-junctions. See Fig.11 for an example of a poorly built strip footing.

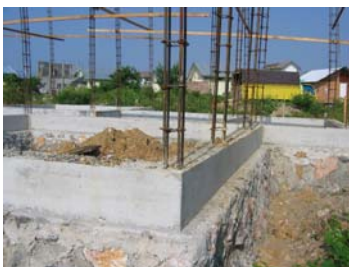
Fig. 12. Typical Build Change foundation beam, Build Change-designed house for CRS

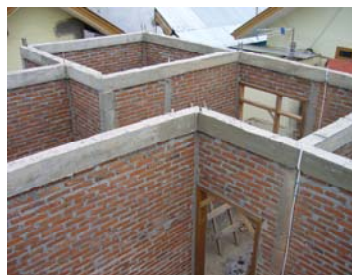
Fig. 13. Typical Build Change ring beam, Build Change-designed house for CRS

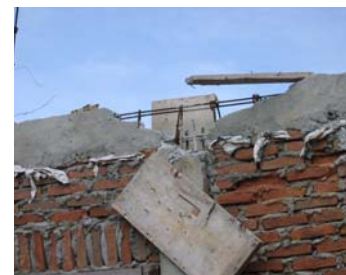
Fig. 14. Bad practice, connections and concrete quality, other organizations

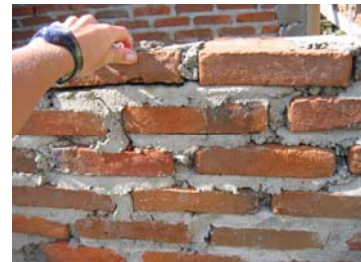
Fig. 20. Typical wall built by other mason

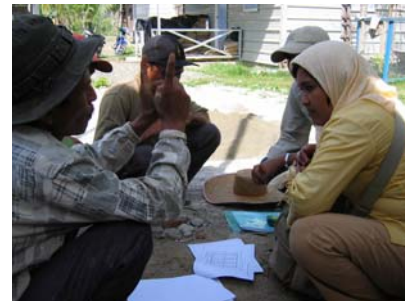
Fig. 21. Builder, homeowner, Build Change architect, and Build Change engineer discuss ring beam-truss connection

Carpentry: Carpentry was the least challenging aspect of the construction process; we found many skilled carpenters, some of whom suggested changes to our truss details that made them simpler to build (Fig. 21). The primary challenge with the timber elements was that some of the window and door frames were produced with timber that wasn't totally dry. The frames would look straight and square when we accepted the order from the vendor, but a few days in the tropical sun, and some of them would warp or split.

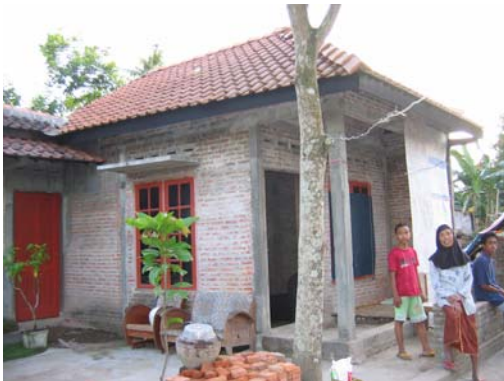
Fig. 22. Well designed and built confined brick masonry house, edge of heavily damaged Pleret (Bantul), S7.83686° E110.41552°, IMG_6636

Many newly built confined masonry houses with reinforced concrete tie columns and bond beams at the plinth and roof levels performed well in these earthquakes. See Figs. 22 and 23 for a well-built confined masonry house with no evidence of damage, on the edge of heavily damaged Pleret. In typical confined masonry practice, the tie columns are cast after the masonry wall was built, flush with the wall, and thus the same width as a brick or block (10 or 11 cm). Smooth reinforcing steel is common in both Central Java and West Sumatra, typically 6 or 8mm in diameter with stirrups ranging from 3 to 6mm in diameter. Stirrups were often spaced at 15 to 25 cm intervals.

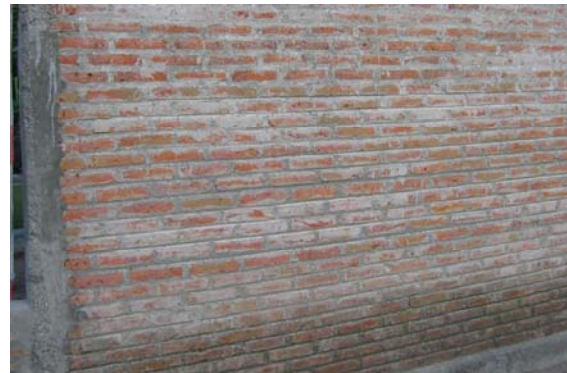
Fig. 23. Well built confined masonry wall, house on edge of heavily damaged Pleret (Bantul), S7.83686° E110.41552°, IMG_6640

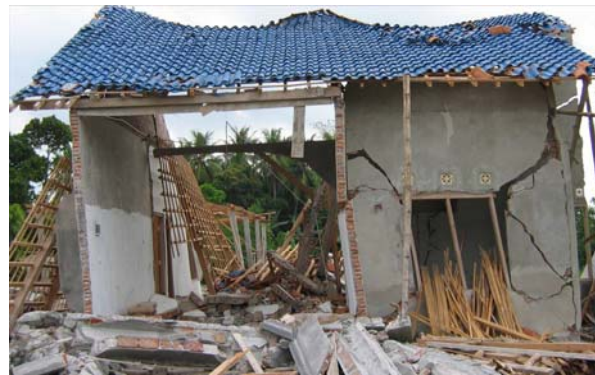
Fig. 24. Confined masonry house under construction, insufficient connections, Pleret (Bantul). S7.87574°, E110.40703°, IMG_6575

In contrast, the house shown in Fig. 24 illustrates many of the shortcomings common to poorly designed and built confined masonry houses in Indonesia – tall slender wall with tendency to overturn, insufficient connections between confining elements, no reinforcement in the wall especially above openings. These flaws, and how Build Change has addressed the flaw in design, are described in the following sections. The problems and solutions are grouped according to the three C's – configuration, connections, and construction quality.

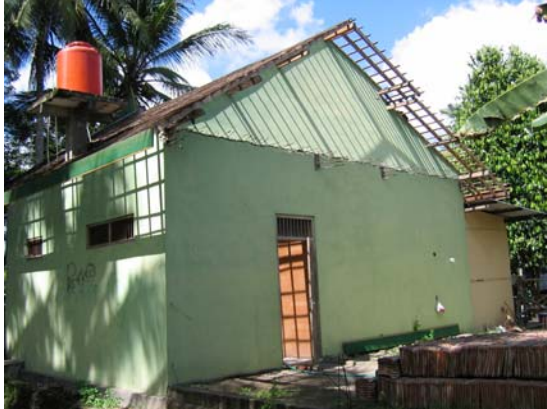
Figure 1. Masonry gable wall overturning in 27 May 2006 Central Java Earthquake, Keputren, Pleret (Bantul) S7.86905° E110.40272°, IMG_6721

Problem: Masonry gables are notoriously poor performers in earthquakes (see Figs. 1 and 2) and should be avoided. Damage and failure to masonry gable walls was widespread throughout all three earthquake-affected regions, and plagued both new and older houses with and without reinforced concrete ring beams. In most cases, gable masonry was neither properly confined nor properly connected to the roof. Cross-bracing between gables was not common.

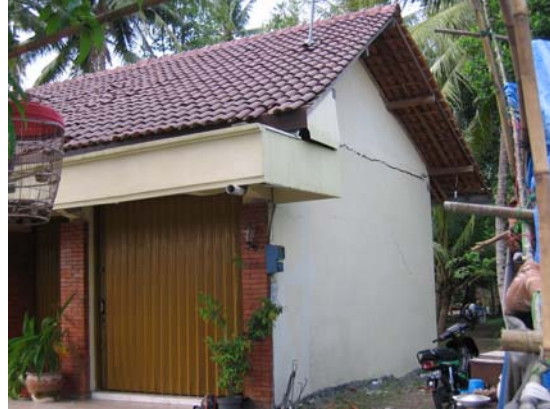
Figure 2. Masonry gable wall overturning in 27 May 2006 Central Java Earthquake, (Bantul) S7.89468°, E110.37341°, IMG_6542

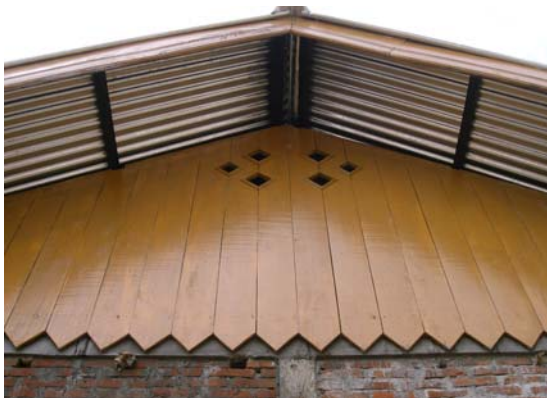
Figure 3. Papan Gable (Maimunah's house designed and built by Build Change, Keunue ue, Peukan Bada, Aceh Besar)

Build Change Solution: REMOVE THE MASONRY ABOVE THE RING BEAM: Shift the truss over to rest on the wall and use a timber or other lightweight cover (Fig. 3). Alternatively, use a hipped roof (Fig. 4) which is the lowest cost alternative, and also performs better in high winds.

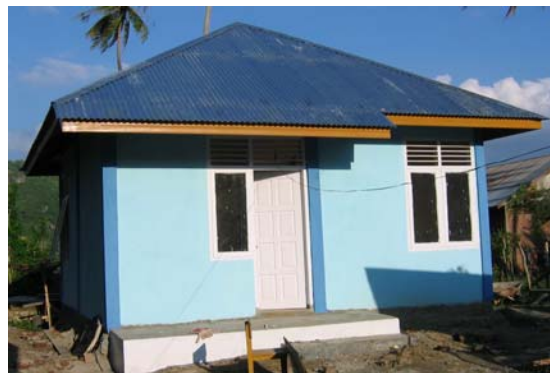
Figure 4. Rabung Empat Roof (Rusdi Razali's house designed and built by Build Change, Keunue ue, Peukan Bada, Aceh Besar)

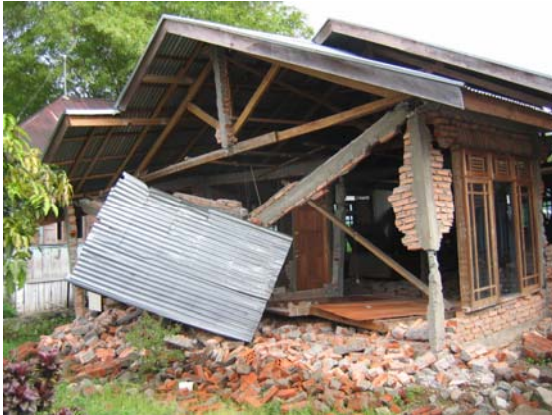
Figure 5. Collapse of front wall in confined masonry house, Padang Panjang, IMG_8831

Problem: Large openings at the front of the house are common. There are many examples from all three earthquakes in which the front of the house has collapsed, while the back of the house remained intact (see Figs (5 and 6). The problem associated with this lack of stiffness in the in-plane direction of walls with large openings and lack of confining elements to restrain masonry panels from failing outwards is exacerbated by the heavy mass of the masonry gable wall.

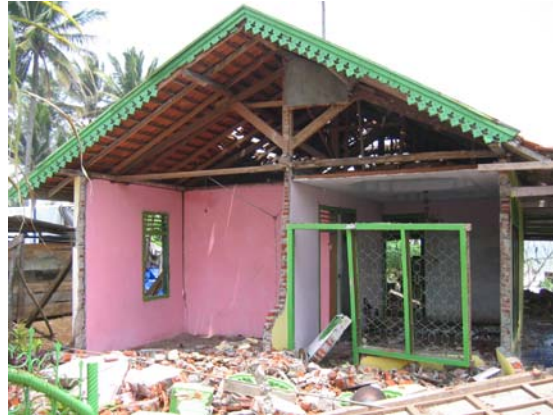
Figure 6. Partially collapsed brick masonry house with RC tie columns and timber bond beams, note partial collapse of masonry gable wall, and lack of in-plane stiffness in front wall, Kec. Lais (North Bengkulu) S3.53217° E102.03771°

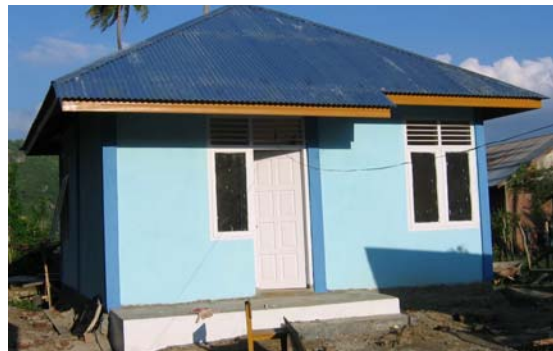
Figure 7. Rabung Empat Roof (Rusdi Razali's house designed and built by Build Change, Keunue ue, Peukan Bada, Aceh Besar)

Build Change Solution (Fig. 7):

Build Change Solution: (1) Avoid the covered terrace by using a simple extended overhang, as shown in Fig. 7. Note that this requires good quality timber, or bracketing to support the overhang. Or, (2) Reduce the mass above the open frame by replacing the masonry, and ensure the connectins are detailed properly (Fig. 12).

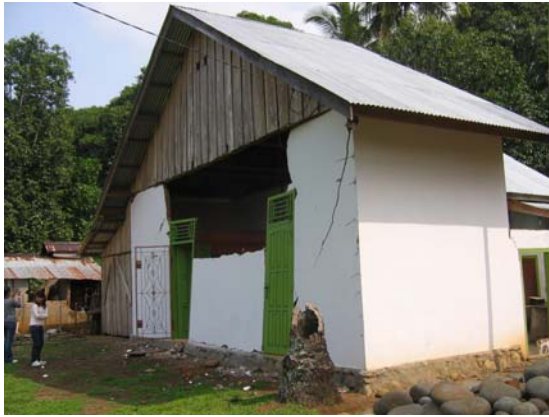
Figure 8. Confined masonry building with overturning failure of tall, unsupported wall, Kec. Airnapal (North Bengkulu)

Problem: Walls upwards of 4m in height and longer than 6m without crosswalls and bracing are common and prone to out-of-plane failure, as illustrated in Fig. 8 for a tall wall and Fig. 9 for a long wall.

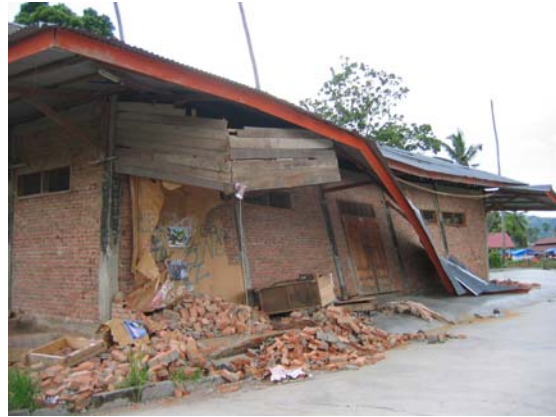
Figure 9. Confined masonry warehouse with overturning failure of long walls without cross-bracing, X. X (X) SX° EX°. IMG 8891

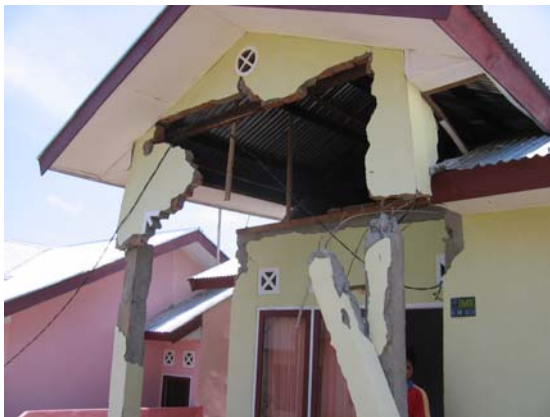
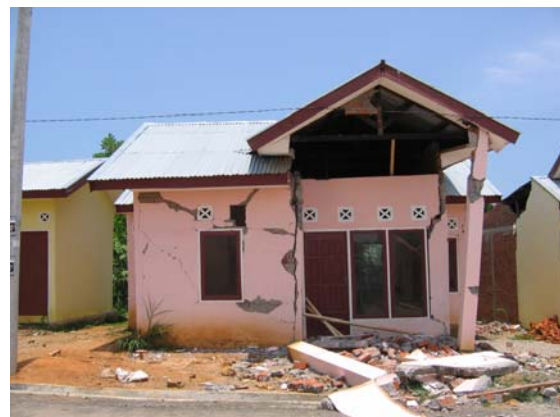
Figure 10. Subdivision of confined masonry houses, damage to covered terrace, Bengkulu. S3.83218° E102.29287°

Figure 11. Subdivision of confined masonry houses, damage to covered terrace, Bengkulu. S3.83218° E102.29287°

Problem: Covered terraces are en vogue in Indonesia. These open frame elements often have heavy, unreinforced and unconfined masonry gable walls above them. The frame elements are poorly detailed and connected to each other and to the main walls of the house. See Figs. 10 and 11.

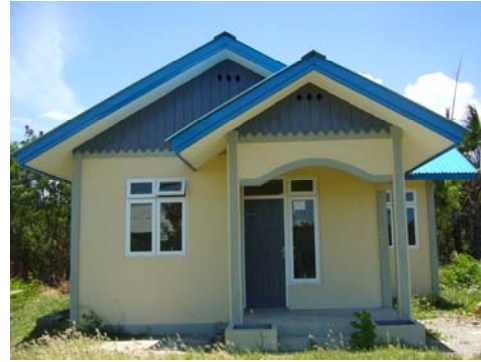
Figure 12. Covered terrace with lightweight wall, Build Change designed house for Catholic Relief Services (Aceh Besar)

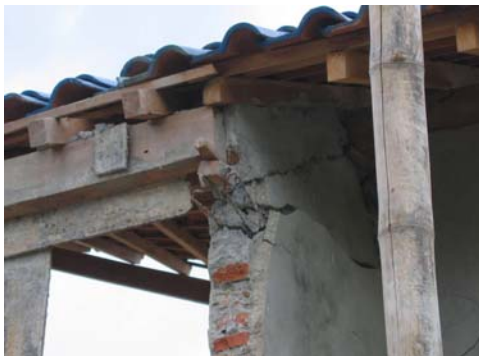
Figure 13. Zoom-in view of ring beam – column connection. IMG_6577

Insufficient connections between reinforced concrete tie columns and bond beams in confined masonry structures contributed to a majority of failures in all three events. The common practice of terminating the bond beam and tie column bars in the joint, while providing a small hook at the end, does not provide sufficient development or anchoring. This problem was widespread in all earthquakes, and a dominant cause of failure for newly-built confined masonry houses in which both tie columns and bond beams were present. In Indonesia, insufficient connections are a problem that plagues both confined masonry and RC frame construction. See Figs 13 through 15 for examples.

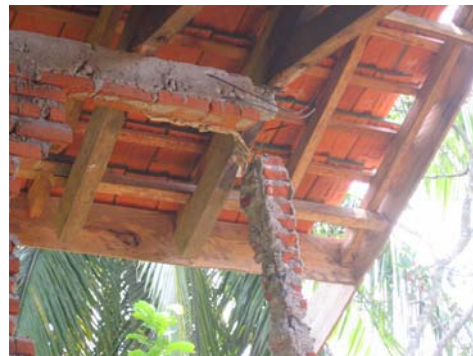
Figure 14. Confined masonry house with failure in masonry walls and connections between tie columns and bond beams, Kec. Airnabal (North Bengkulu)

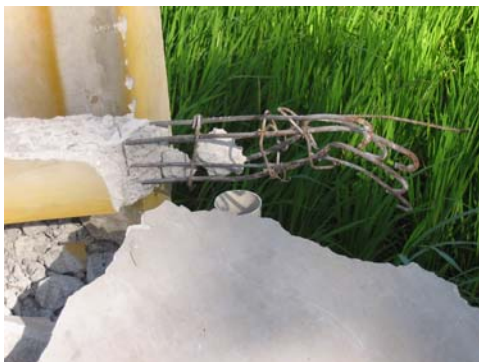
Figure 15. Connection failure, RC frame building, Central Java

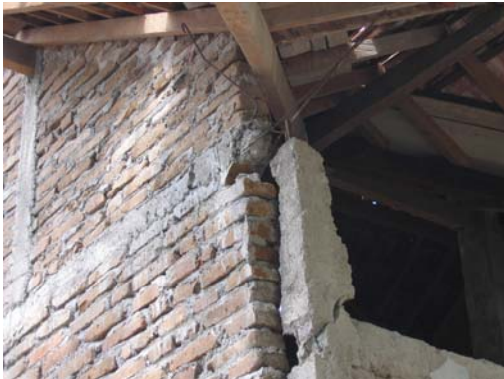
Figure 16. Insufficient connection between wall and tie column and between tie column and bond beam, Pleret (Bantul) S7.88174° E100.40869°, IMG_6746

Problem: Critical to good performance of confined masonry buildings is the connection between the wall and tie columns. Separation between wall and confining elements occurred in many houses in all earthquakes. See Figs. 16 and 17.

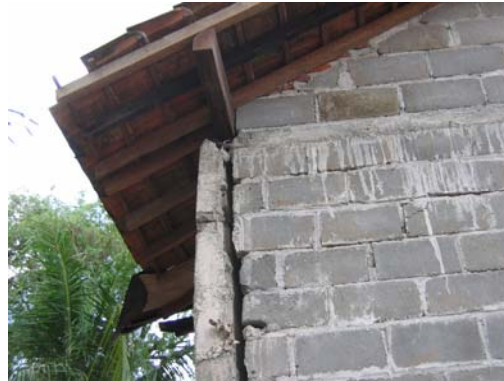
Figure 17. Insufficient connection between wall and tie column and between tie column and bond beam, Segoroyoso, Pleret (Bantul) S7.88174° E100.40869°, IMG_6749

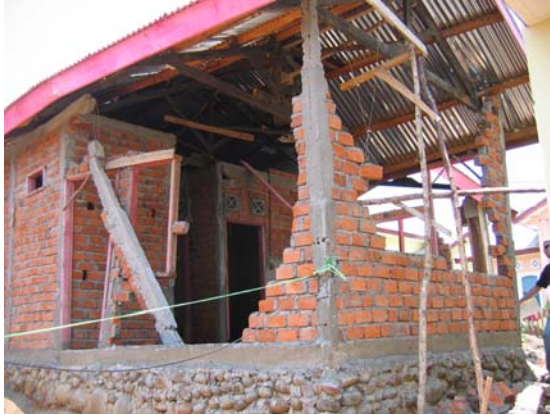
Fig. 19. Subdivision of confined masonry houses, collapse of masonry wall exacerbated by insufficient connections, Bengkulu. S3.83218° E102.29287°

The first line of defense in a confined masonry structure in earthquake strong shaking is a well-built masonry wall. Typical single story confined masonry houses in Indonesia have been shown to perform well in earthquakes, even when the tie columns are small in section and use smooth bars of small diameter, provided the masonry wall is well constructed, with adequate bonding between bricks and mortar. See Figs. 19 and 20 for examples of wall collapses with columns and roof intact. Weak bonding is clearly a contributor to failure (Fig. 21); bricks were not soaked in water before building wall, and/or the mortar mix was too dry.

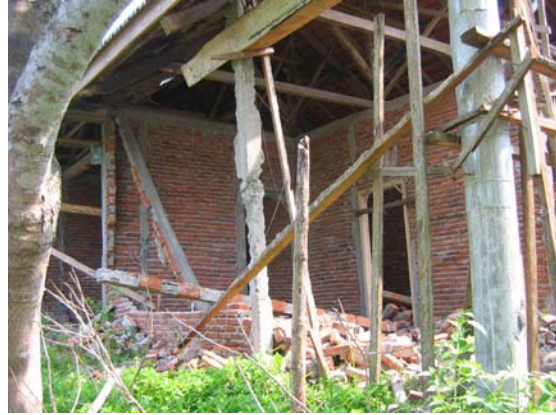
Fig. 20. Confined masonry house with failure in masonry walls and connections between tie columns and bond beams, Kec. Airnapal (North Bengkulu)

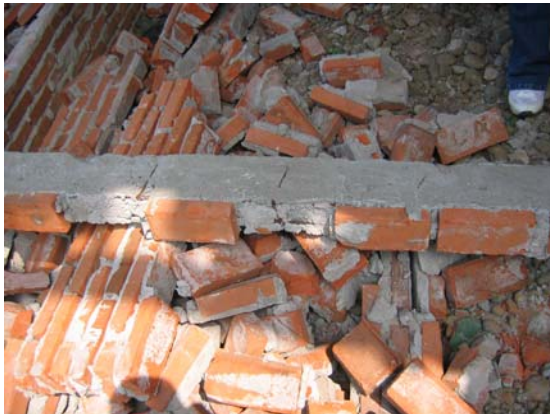
Fig. 21. Close up view of collapsed ring beam and wall, same as Fig. 20. Failure plane between top of mortar bed and bottom of brick above it.

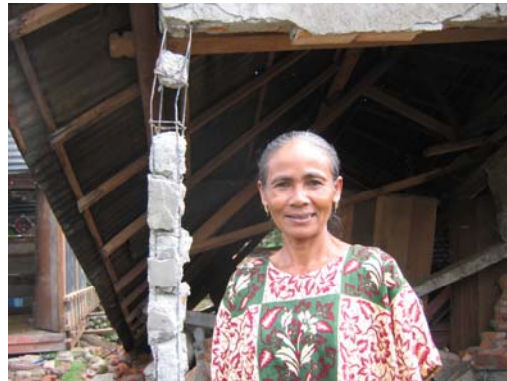
Fig. 22. Homeowner standing in front of her collapsed wall, note quality of concrete, Padang Panjang, S (X) SX° EX°, IMG_8840

Problem: Poor quality concrete also contributed to failures. See Fig. 22. Same solutions apply: follow suggestions in previous sections on construction quality.

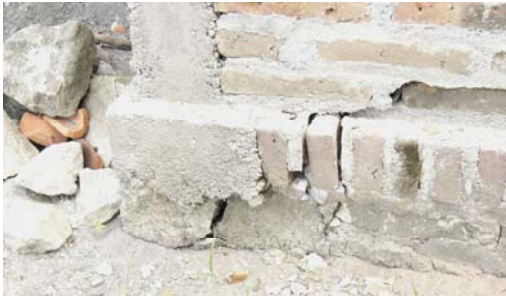
Fig. 23. Displacement along wall/foundation interface, Tegal Kebong Agung, Imogiri (Bantul) S7.93434° E110.36667°, CIMG1769

We have seen very little earthquake-induced damage to confined masonry houses in Indonesia that could be attributed to a soil or foundation problem. In the Central Java event, we found one example of sliding along the wall-foundation interface; in this case, there was no foundation beam. Effects of liquefaction were observed in one village in the Bengkulu event (Fig. 24).

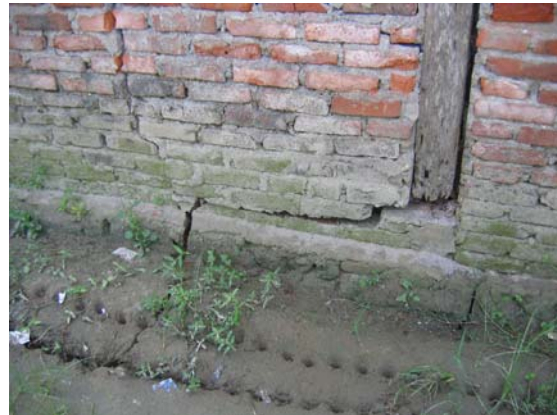
Fig. 24. Cracks in foundation and walls associated with settlement and tilt on liquefiable soils, Lempuing (Bengkulu), S3.82799° E102.28473°
