SEISMIC RETROFIT OF CONFINED MASONRY HOUSES IN HAITI: LESSONS FROM IMPLEMENTATION

Keywords: Retrofit, Housing, Confined Masonry, Haiti

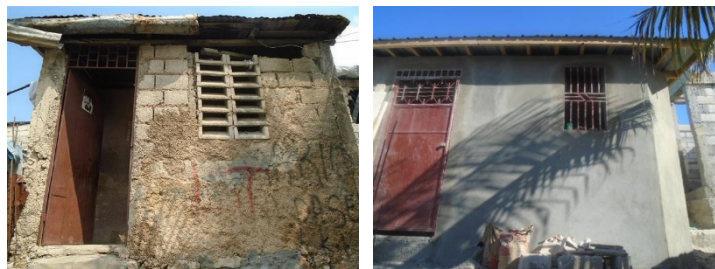
Fig. 4: A home in Port-au-Prince before (left) and after (right) a seismic retrofit

Retrofitting is particularly suited to the homeowner driven approach because the technical solutions for the retrofit can be varied to suit the needs of the homeowner. For example, in cases where a homeowner would like to add a new story to the house in the future, the retrofit can be designed so that the existing home can safely resist the additional earthquake demands from the future level when it is constructed. Homeowner satisfaction is further increased because often retrofitted houses are improved, safer versions of the houses that the same families lived in before the earthquake [8]. See Fig. 4 for an example of a retrofitted house.

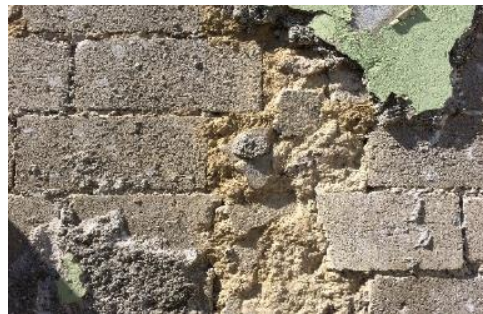
Fig. 6 – Poorly repaired wall crack

Cracks in existing walls can be superficial and concern only the cement plaster covering; in that case the plaster can be removed around the crack and repaired. If the masonry is cracked on only one side of the wall, repair during the retrofit should be made. In the cases where the crack is visible on both sides of the masonry, it is recommend to replace the damaged portion of wall. In Fig. 6, the crack in the wall was previously repaired: first filled with unwashed sand mortar and pieces of rubble, and then plastered over. This condition would require a larger, more significant repair with adequate construction materials, and potentially replacement of the wall.

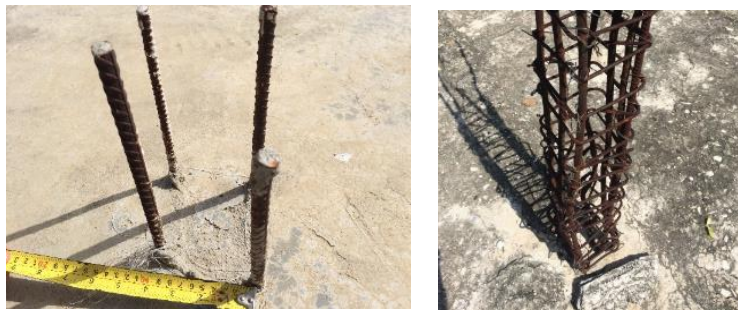
Fig. 7 – Left – Existing column extension with (3) #4 and (1) #3 bars
Right – Existing column extension with smooth rebar and stirrups already placed

Very few existing confining columns are built to standards for new construction, see Fig. 7; nevertheless the Manual procedures do not aim to replace all the columns of a house. Engineering judgement is needed to evaluate the adequacy of an existing column depending on the role of the column in the structure. For example, a confining column in a deteriorated state, particularly with corroded reinforcing, or very poorly built should be replaced. A confining column that does not meet all of the new construction standards, but is in decent state may be kept and still serve to adequately confine an existing wall.

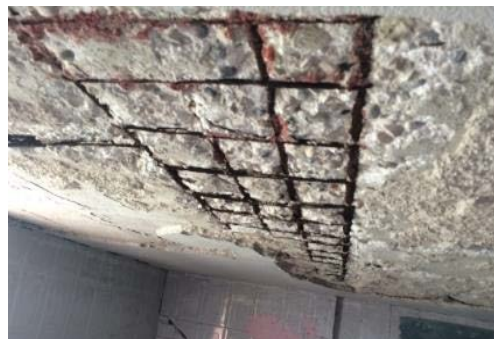
Fig. 8 - Existing slab in poor condition

During the example project in Carrefour Feuille, retrofits of 35 houses with existing suspended slabs were performed. In the evaluation phase, nine of the houses (approximately one quarter) were identified to need slab replacement due to the poor condition of the existing slab, see Fig. 8. However, during the construction phase, an additional four houses were added to the number of houses needing slab replacement [9]. This represents a total of about 40% of the existing slabs requiring replacement (foreseen and unforeseen), a 15% increase due to unforeseen conditions.

It is common for the ceiling plaster below the slab to appear to be in good condition, but when construction starts and the slab vibrates more than usual, the plaster can collapse and expose corroded reinforcing (Fig. 8). The high rate of slab replacement required (40%) can be attributed to the poor construction techniques used during the original slab pour – primarily lack of adequate concrete cover below the reinforcing.
