Performance of Confined Masonry Buildings in the February 27, 2010 Chile Earthquake

Svetlana Brzev, Maximiliano Astoza and Maria Ofelia Moroni Yadlin

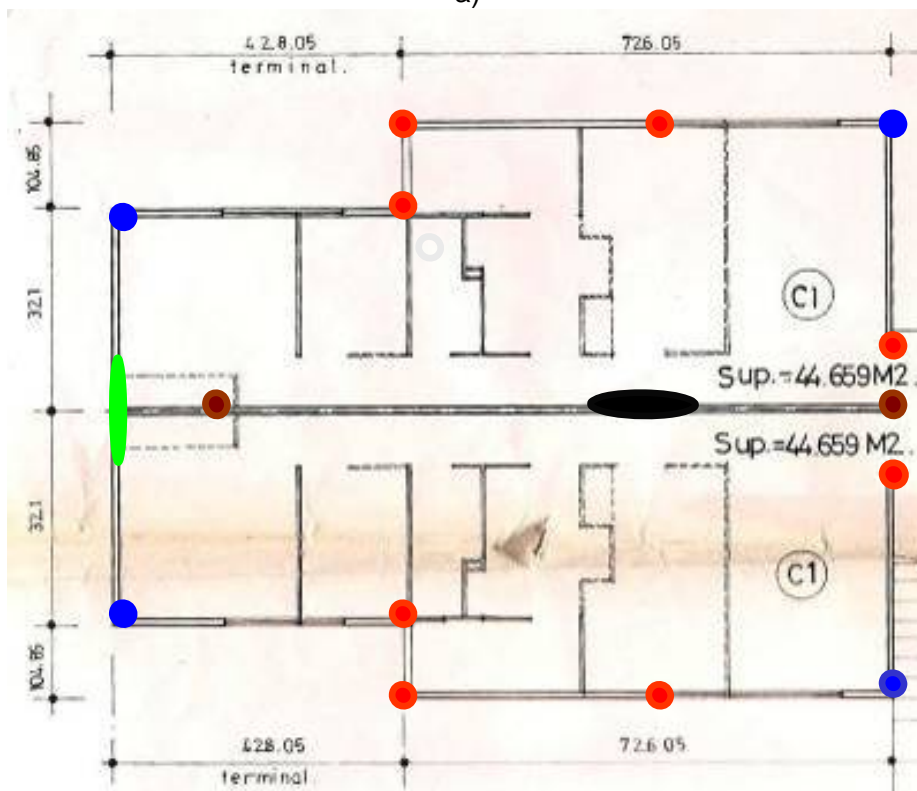
b)

These wide columns replaced tie-columns at some locations (this practice is followed in medium-rise confined masonry construction in Chile). A typical floor plan is shown in Figure 11 b. It is believed that the building location and geotechnical effects, in addition to a low wall density in the north-south direction (less than 1 % calculated on a floor basis), were the key factors contributing to the collapse.

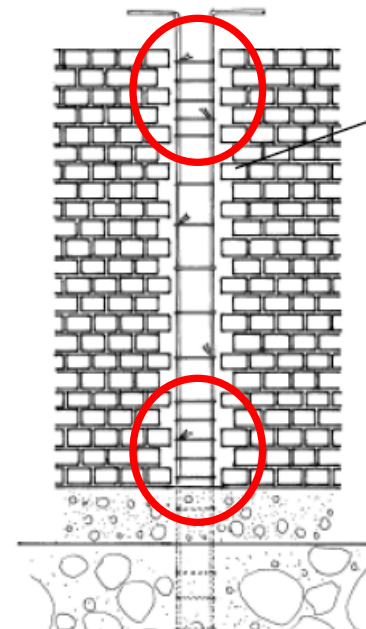
Figure 13. Inadequate confinement in the end zones of RC tie-columns: a) buckling of longitudinal reinforcement (note an excessively large tie spacing), and b) a closer tie spacing prescribed at the ends of RC tie-columns (Blondet, 2005).

Inadequate confinement at the ends of RC tie-columns was observed in most cases when these regions were exposed due to earthquake damage, as shown in Figure 13 a. According to the NCh 2123, a closer tie spacing of 100 mm is required in tie-column end regions compared to that in the middle portion of the column (200 mm). A typical detail showing tie spacing requirements for end regions is shown in Figure 13 b. This practice was not observed in any of the damaged buildings. A possible reason is the use of prefabricated reinforcement cages with uniform tie spacing up the tie-column height. An enhanced confinement in the end zones of RC tie-columns is expected to prevent a premature buckling when increased axial compression stresses develop in localized areas where masonry is completely disintegrated, as discussed in Section 2.2.

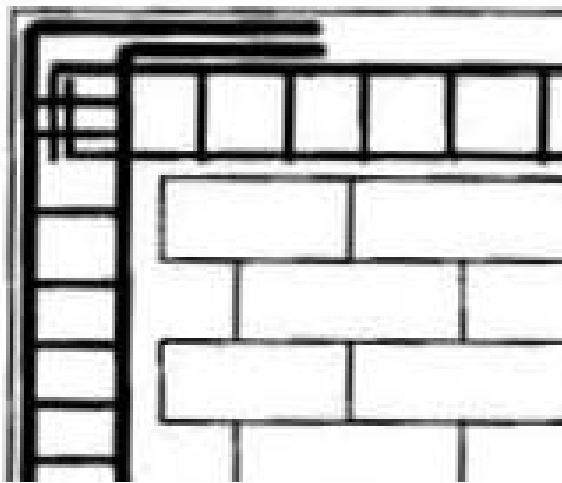
Figure 14. Absence of confinement in the tie-beam-to-tie-column joint region: a) interior tie-column; b) exterior tie-column, and c) drawing detail showing additional ties in the joint region (Credit: A. San Bartolomé).

Absence of ties in the joint region was observed in all cases where joints were exposed (see Figure 14 a). This deficiency could cause a shear failure in the joint region, as shown in Figure 14 b. Chilean codes do not contain specific requirements for providing additional ties in the joint region, which could be similar to a detail shown in Figure 14 c.

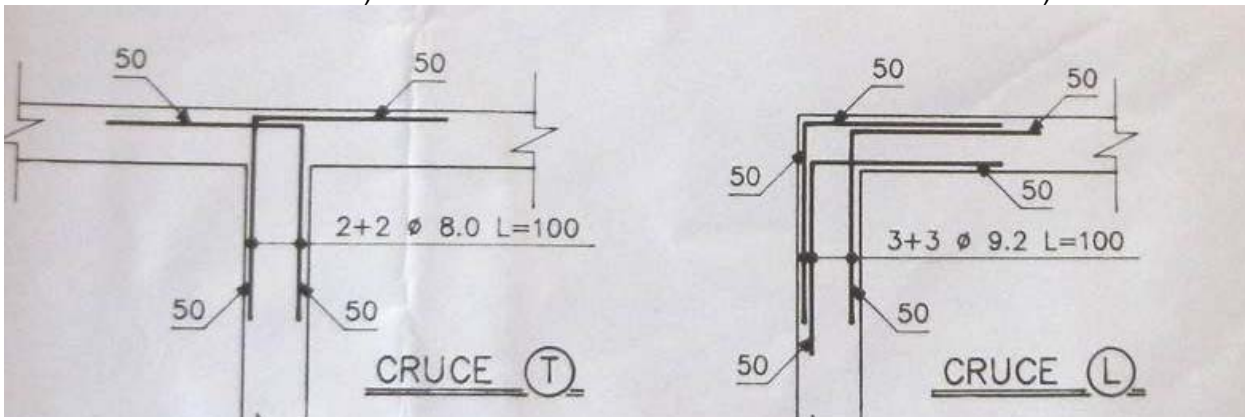
Discontinuous longitudinal reinforcement at the RC tie-beam intersections is shown in Figure 15 a and b. This is contrary to Chilean detailing practice for this location, as illustrated by a drawing detail shown in Figure 15 c. It should be noted that reinforcement cages for tie-beams and tie-columns are often assembled off the building site, however additional “continuity reinforcement” should be provided once the cages are placed in the final position.

Figure 15. Inadequate anchorage of tie-beam reinforcement: a) typical “corner” building; b) tie-beam intersection showing a discontinuity in tie-beam reinforcement, and c) a drawing detail showing “continuity reinforcement” at the intersection (plan view) – for a different building.
