Performance of Confined Masonry Buildings in the February 27, 2010 Chile Earthquake

Svetlana Brzev, Maximiliano Astroza and Maria Ofelia Moroni Yadlin

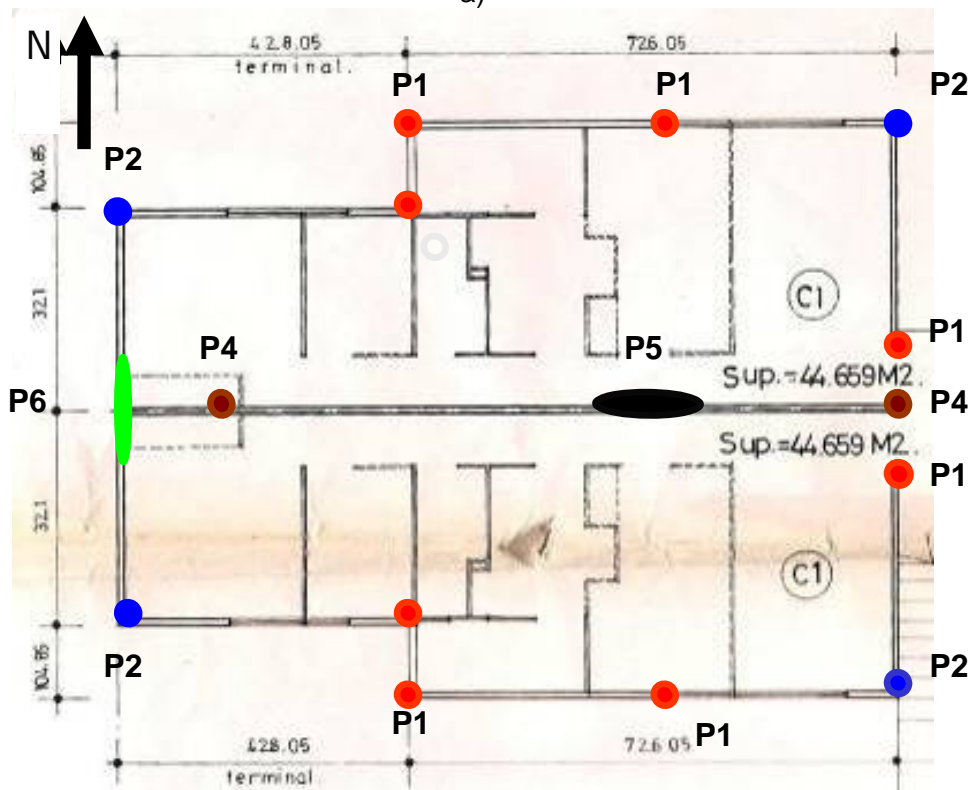
b)

The collapsed building shifted by approximately 1.5 m in the north direction (towards the slope), as shown in Figure 11 a. Note that building B experienced more extensive damage than building A. The damage in all buildings was more pronounced in the north-south direction (transverse direction of the building plan). The collapse was initiated by the shear failure of the transverse walls, which was followed by the out-of-plane failure in the longitudinal walls (horizontal cracks due to out-of-plane seismic effects were observed in the longitudinal wall of building B). The walls were constructed using 140 mm thick hollow clay block units. RC tie-columns had different cross-sectional dimensions

depending on the location: length ranged from 140 to 200 mm, and depth was equal to the wall thickness. In addition, a few wide RC columns (700 to 900 mm long and 140 mm wide) lightly reinforced with nominal vertical and horizontal reinforcement were also found in these buildings. These wide columns replaced tie-columns at some locations (this practice is followed in medium-rise confined masonry construction in Chile). A typical floor plan is shown in Figure 11 b. It is believed that the building location and geotechnical effects, in addition to a low wall density in the north-south direction (less than 1 % calculated on a floor basis), were the key factors contributing to the collapse.

- RC Tie-Columns:
- P1 = 15x14 cm
 - P2 = 20x14 cm
 - P4 = 15x15 cm
 - P5 = 70x15 cm
 - P6 = 90x14 cm

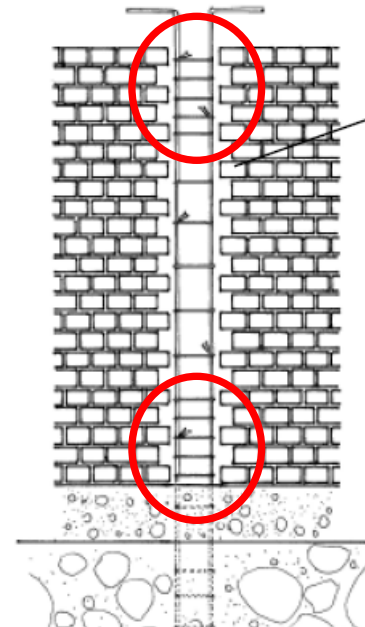
Inadequate amount of transverse reinforcement at the ends of RC tie-columns was observed in most cases when these regions were exposed due to earthquake damage, as shown in Figure 13 a. According to the NCh 2123, a closer tie spacing of 100 mm is required in tie-column end regions compared to that in the middle portion of the column (200 mm). A typical detail showing tie spacing requirements for end regions is shown in Figure 13 b. This practice was not observed in any of the damaged buildings. A possible reason is the use of prefabricated reinforcement cages with uniform tie spacing up the tie-column height. Transverse reinforcement in the end zones of RC tie-columns is expected to prevent shear failure and buckling of longitudinal reinforcement in localized areas where masonry is completely disintegrated, as discussed in Section 2.2.

Figure 13. Inadequate confinement in the end zones of RC tie-columns: a) shear failure and buckling of longitudinal reinforcement (note an excessively large tie spacing), and b) a closer tie spacing prescribed at the ends of RC tie-columns (Blondet, 2005).

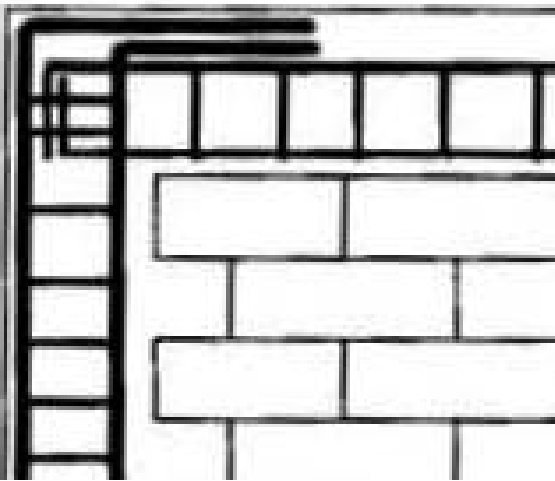
Absence of ties in the joint region was observed in all cases where joints were exposed (see Figure 14 a). This deficiency could cause a shear failure in the joint region, as shown in Figure 14 b. Chilean codes do not contain specific requirements for providing additional ties in the joint region, such as shown in Figure 14 c.

Figure 14. Absence of confinement in the tie-beam-to-tie-column joint region: a) interior tie-column; b) exterior tie-column, and c) drawing detail showing how additional ties in the joint region could be accommodated (Credit: A. San Bartolomé).
