## SEISMIC EVALUATION AND RETROFIT FOR REDUCING THE VULNERABILITY OF HOUSING IN COLOMBIA: DEVELOPMENT AND IMPLEMENTATION

D. Nacif Hartley<sup>(1)</sup>, M. L. Blaisdell<sup>(2)</sup>, J. Caballero<sup>(3)</sup>, E. Hausler Strand<sup>(4)</sup>

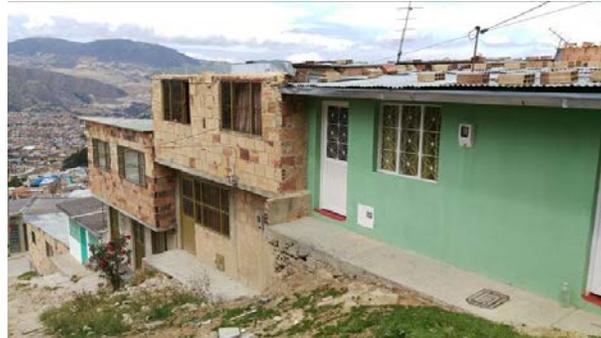
Engineers visited each of the houses that had been prequalified legally for the subsidy, and carried out structural evaluations in accordance with the Manual procedures – documenting the existing conditions and completing the deficiency identification checklist. Fig. 2 shows a typical street in one of the project neighborhoods. The engineers found nearly every type of deficiency covered by the Manual, but there were some items that were more common in the houses evaluated. The most common structural issues found in the informal houses evaluated in the southern areas of Bogotá are identified in Table 1. The evaluation not only identifies potential deficiencies in the structure, but also in some non-structural elements that could compromise occupant safety. Regarding the non-structural elements, the most common issue found was unconfined masonry parapets at the façade of the house, particularly in one-story buildings.

Fig. 2 – One and two story houses in the Usme neighborhood
